DRAFT Minutes of the meeting of the Leisure, Amenities & Environment Committee held at Community House on Tuesday 9th January 2024 at 7.30pm

Property Condition Report

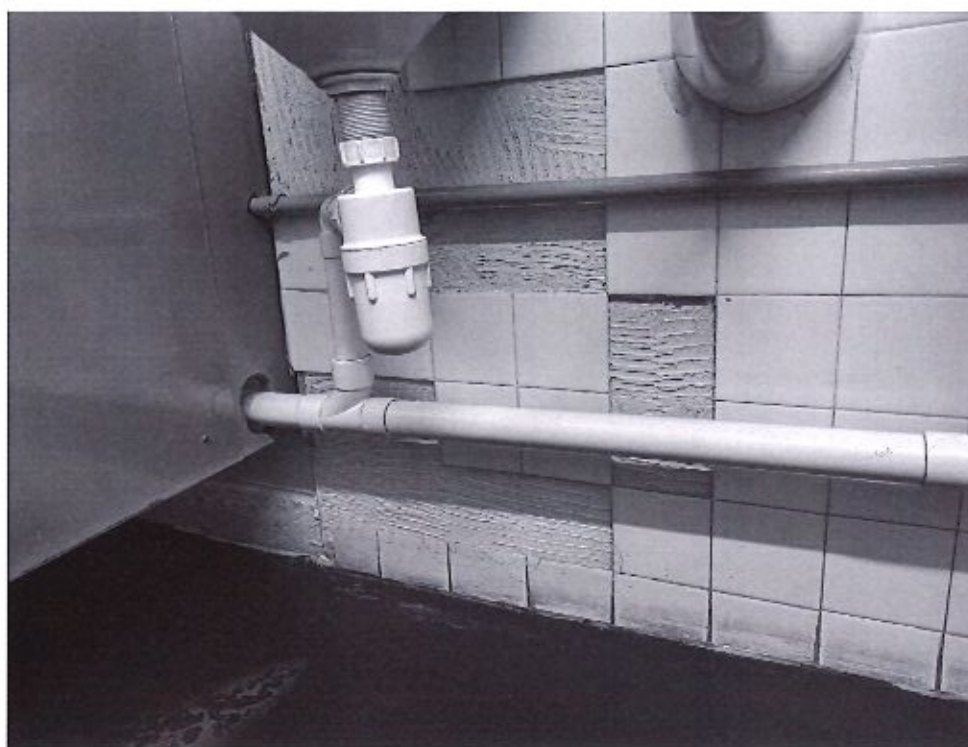
Photograph 41

Photograph:	Wall tiling under urinals
Defect:	Missing ceramic tiles

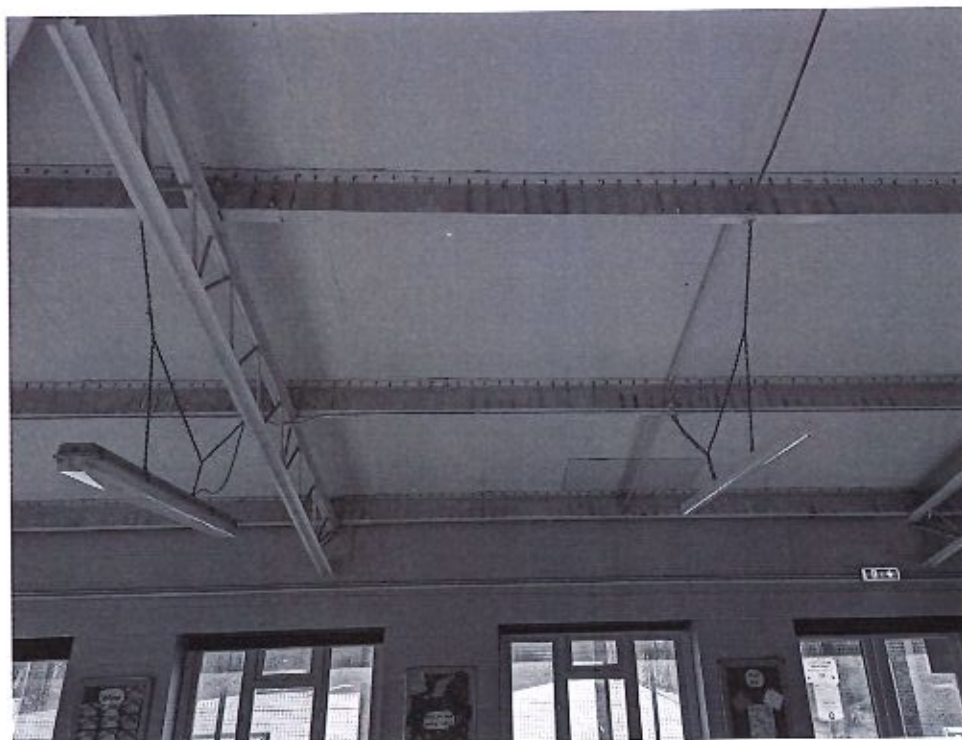
Photograph 48

It is understood that the roof leaks from time to time and the sheet steel roof covering shows evidence of repairs to the joint laps between sheets and replacement of the fixing screws. Internally there is evidence of water dripping from the fixing screws and tracking down the steel purlins. It is unclear if the replacement of the screws has prevented this issue. It is possible that the staining on to the purlins is from condensation forming on the screws as they create a cold bridge to the outside.

Photograph:	Ceiling Main Hall
Defect:	Evidence of water ingress through sheet fixings

- to establish if asbestos is present;
- to review the fire risk assessment to ensure the safety of occupants;
- to fully establish the cause of the water leaks from the roof and provide repair and upgrade options; and
- to assess the potential to reduce carbon emission in support of the Council's net zero commitments.

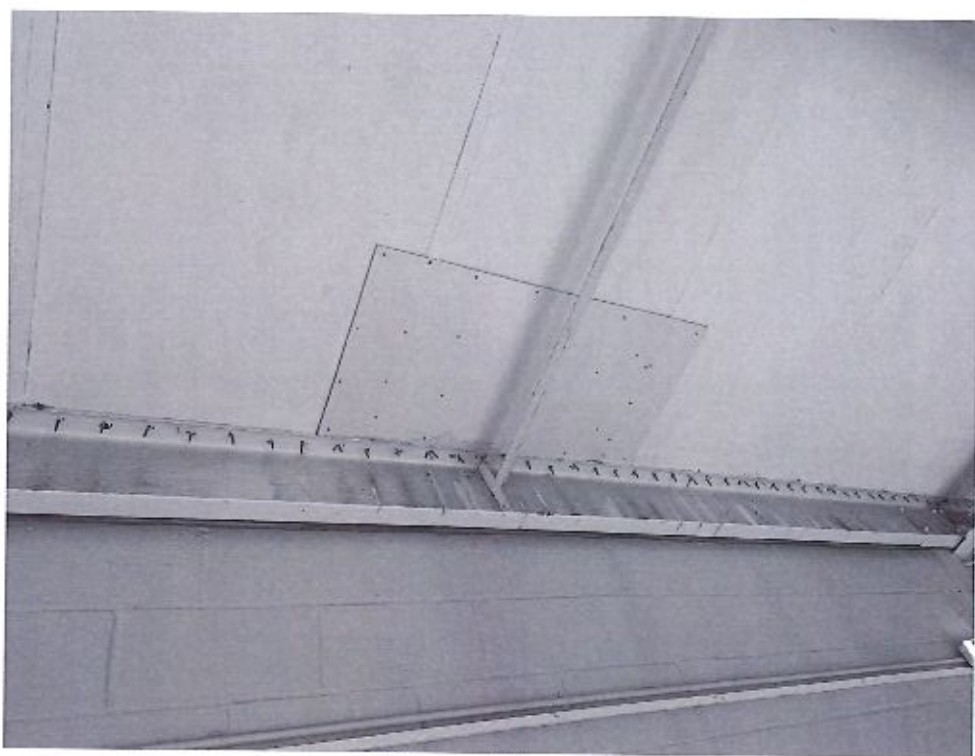
Photograph 49

Photograph:	Main Hall Ceiling
Defect:	Evidence of previous patch repair to ceiling

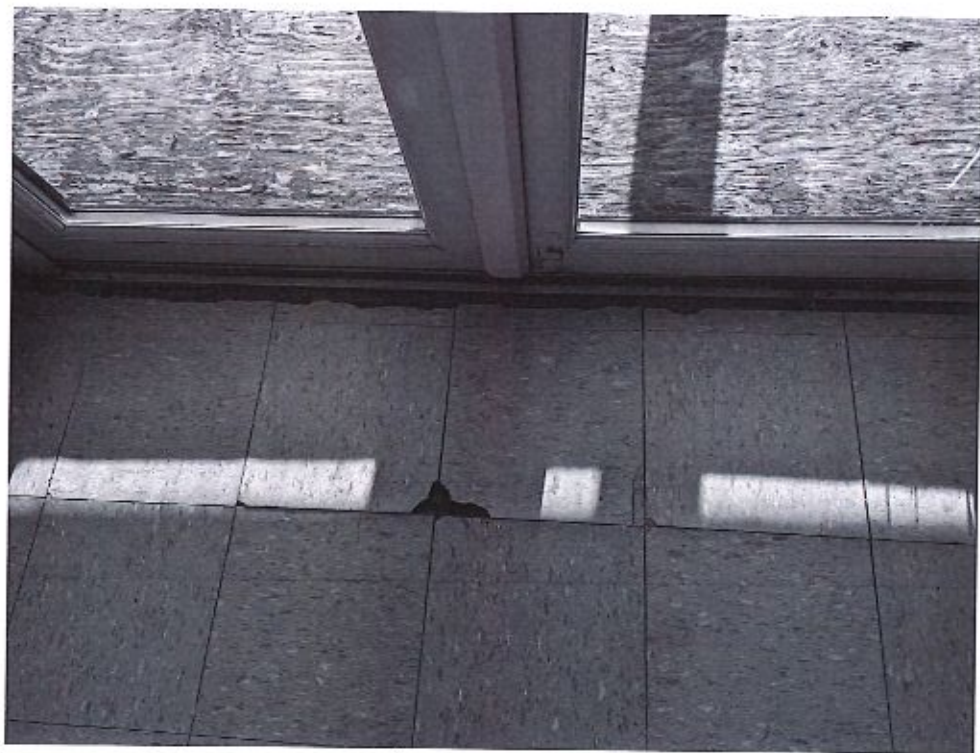
Photograph 50

Photograph:	Main Hall floor
Defect:	Vinyl tiles lifting and broken on fire escape door threshold

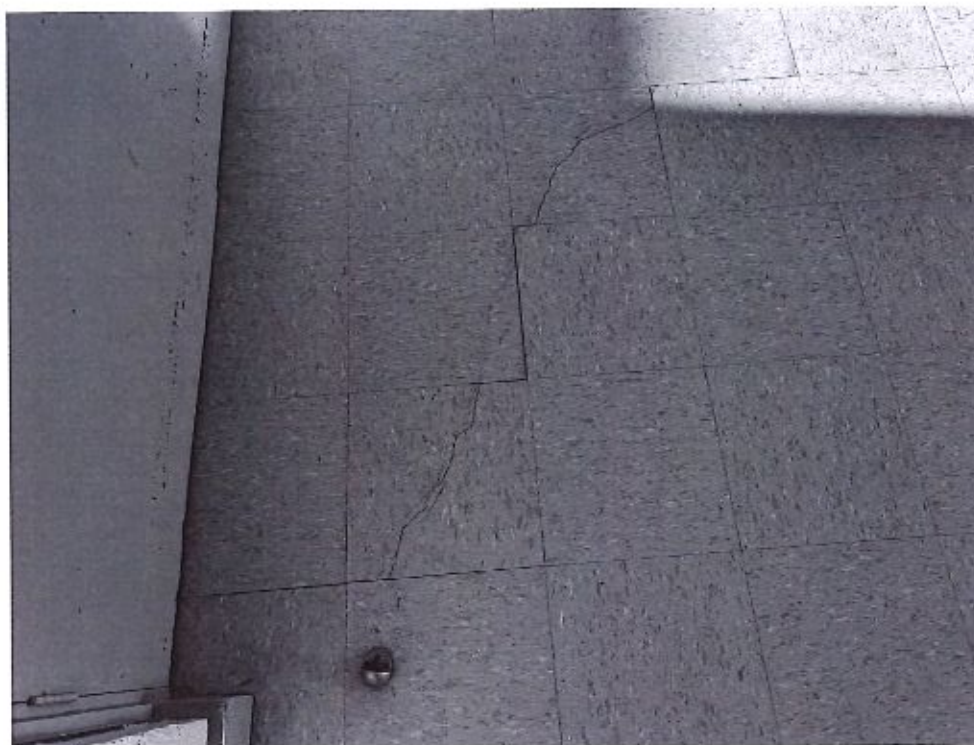
Photograph 51

Photograph:	Floor adjacent to main hall storage
Defect:	Crack running across tiles

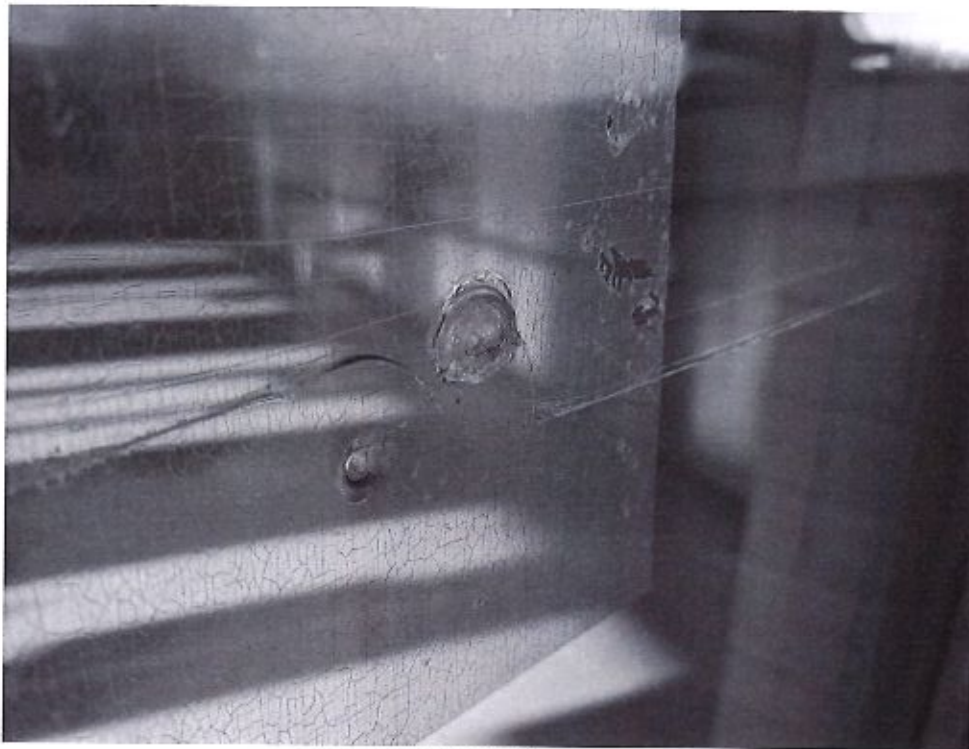
Photograph 53

Photograph:	Glazing in folding doors to external area
Defect:	Glass broken and cracked

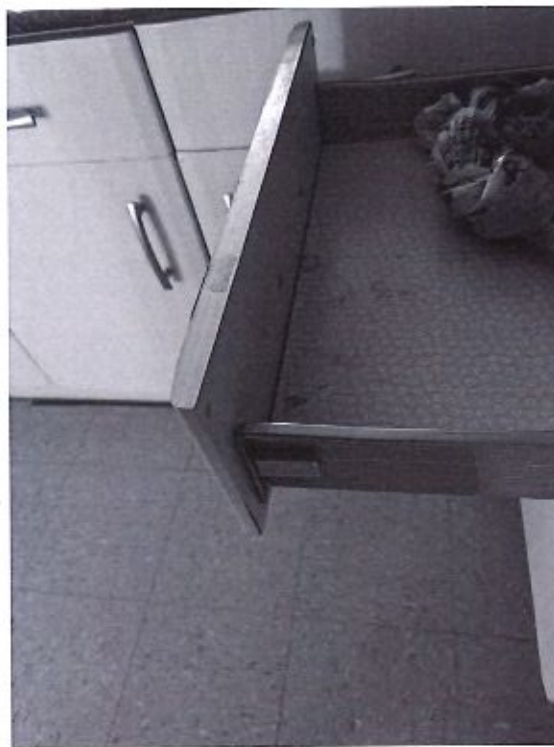
Photograph 63

Photograph:	Kitchen drawer
Defect:	Generally worn

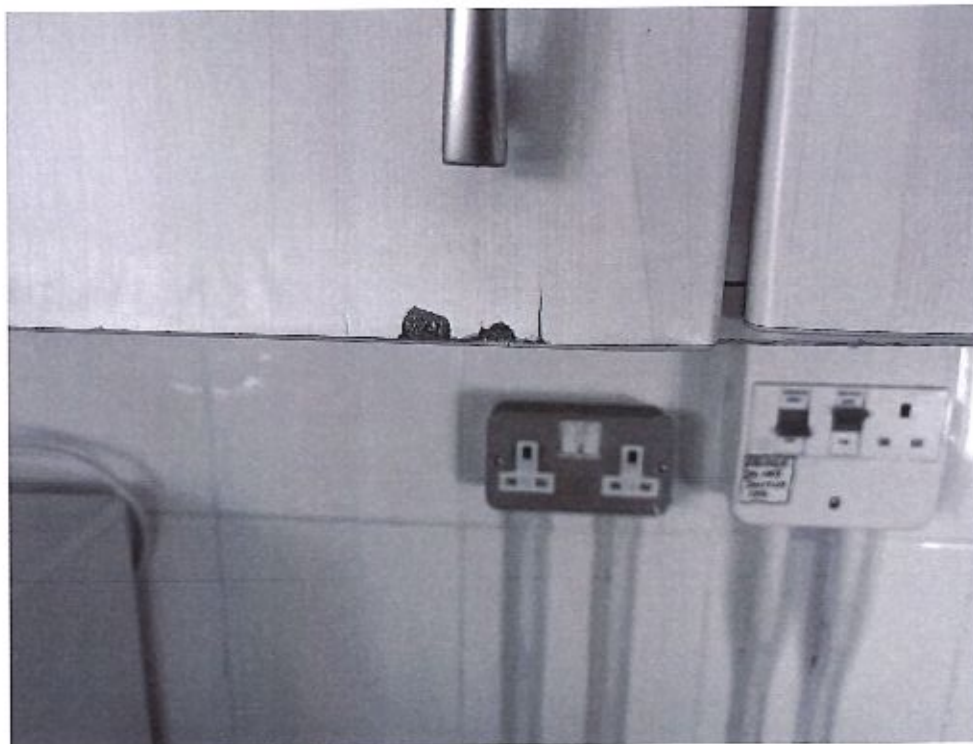
Photograph 64

Photograph:	Kitchen cabinet door
Defect:	Damage to door

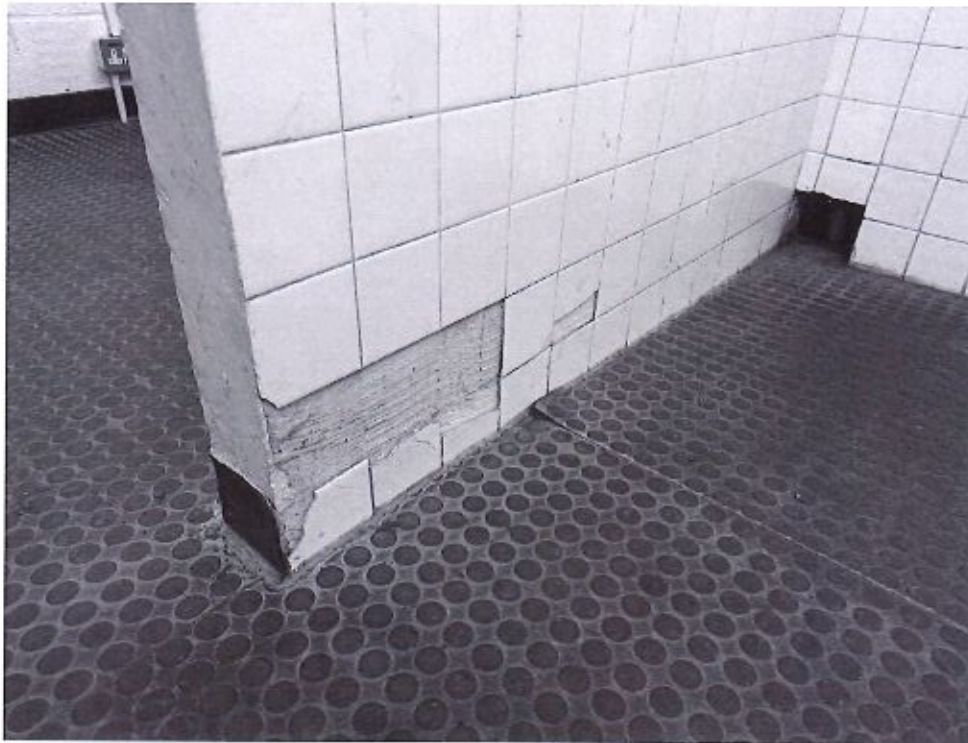
Photograph 73

Photograph:	Wall tiling in shower area
Defect:	Broken and missing tiles

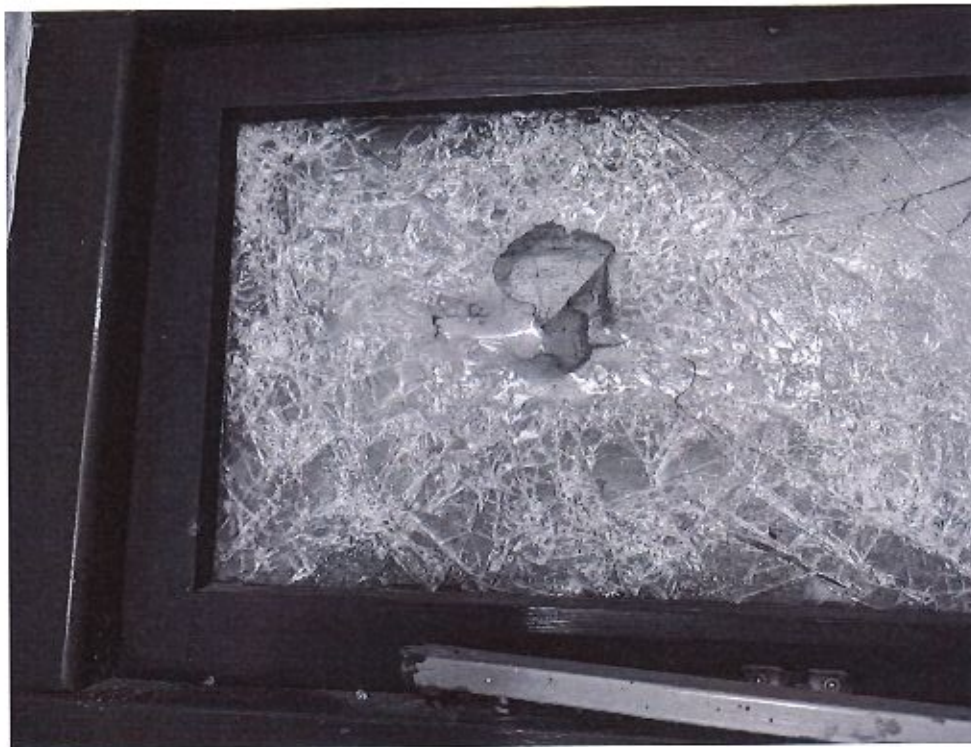
Photograph 75

Windows are a mix of timber, uPVC and aluminium, some of the original timber windows to the changing rooms have been overboarded from the outside, however there are still broken glazing units accessible from inside. The uPVC and aluminium windows are presumed to be replacements to the original installations and are in sound condition.

Photograph:	Timber windows boarded over from outside
Defect:	Broken glass in most windows

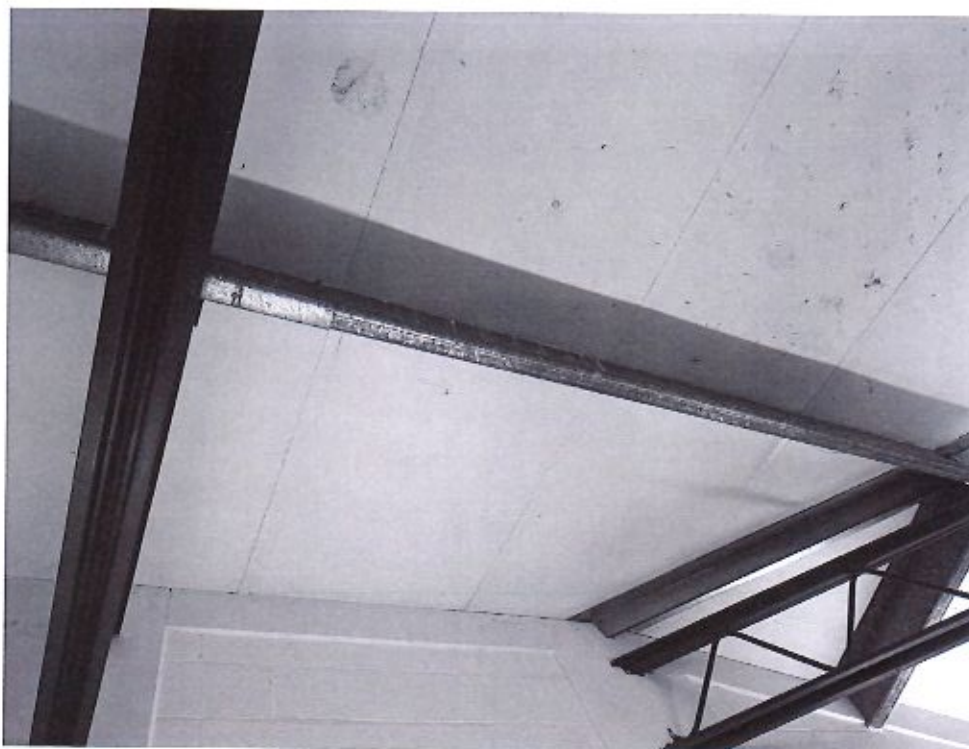
Photograph 77

Photograph:	Changing room ceiling
Defect:	Some staining to ceiling

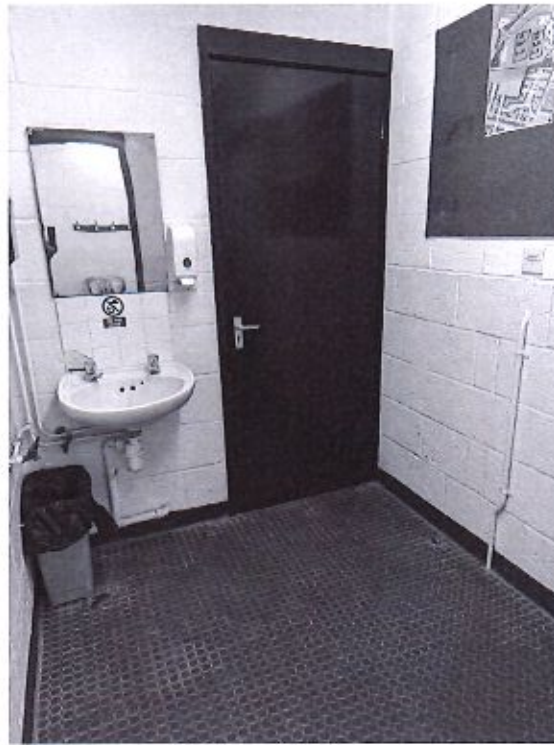
Photograph 91

Photograph:	Hand basin and connecting door to Changing room 1
Defect:	Broken ceramic tiling to splashback

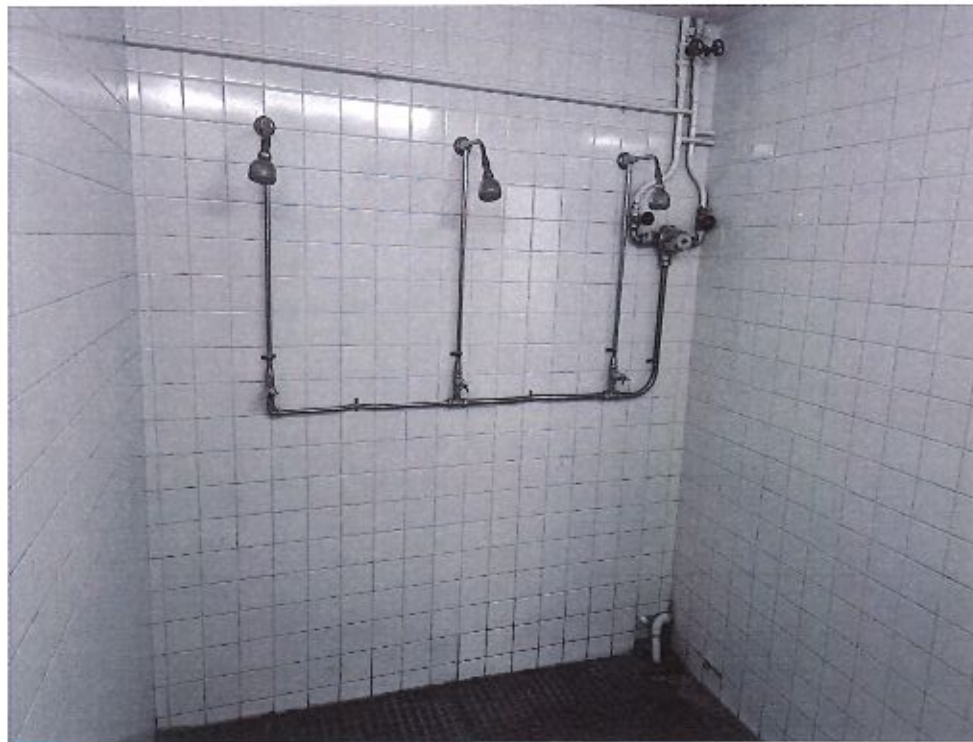
Photograph 92

Photograph:	Shower area
Defect:	Broken and damaged ceramic tiling

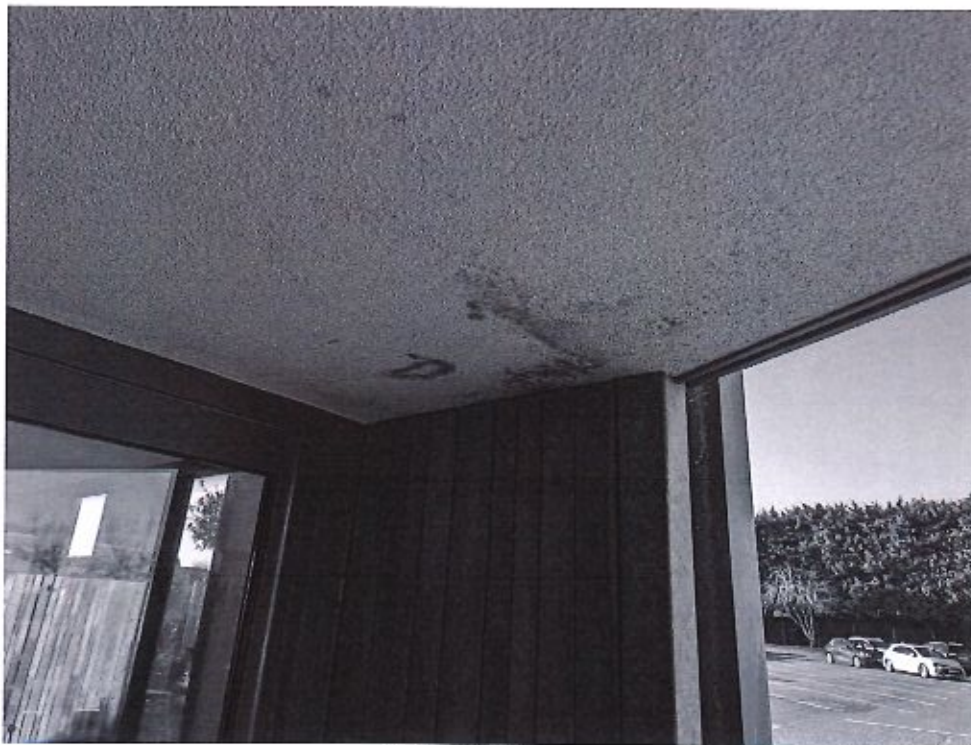
Photograph 98

Photograph:	Soffit to entrance canopy
Defect:	Staining to soffit

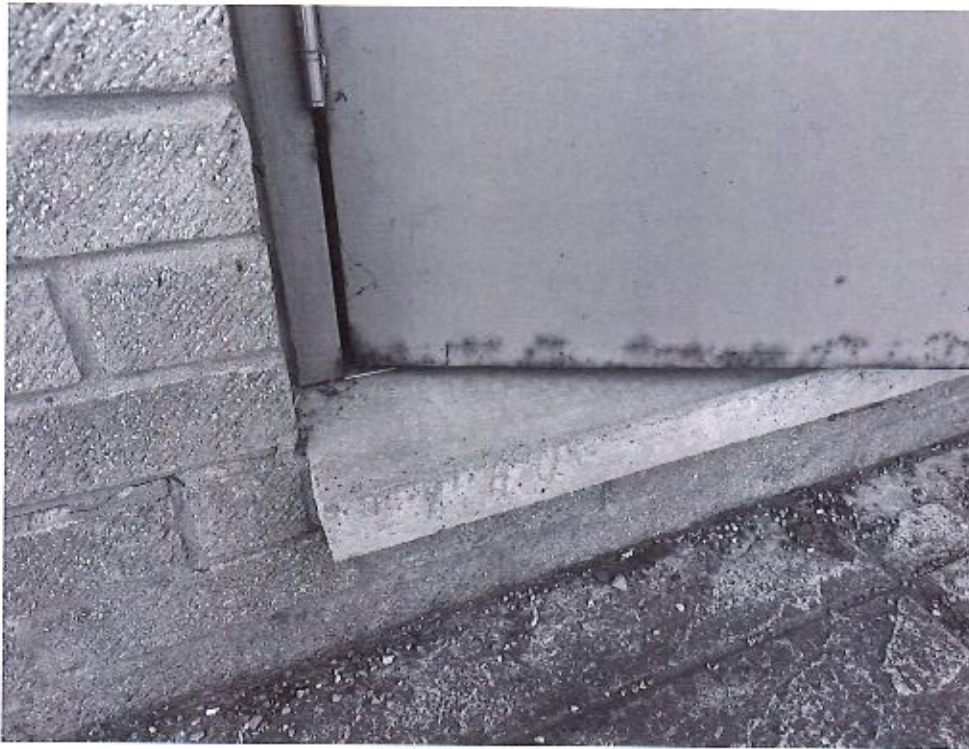
Photograph 101

Photograph:	Steel door to Referee's room
Defect:	Corrosion to door

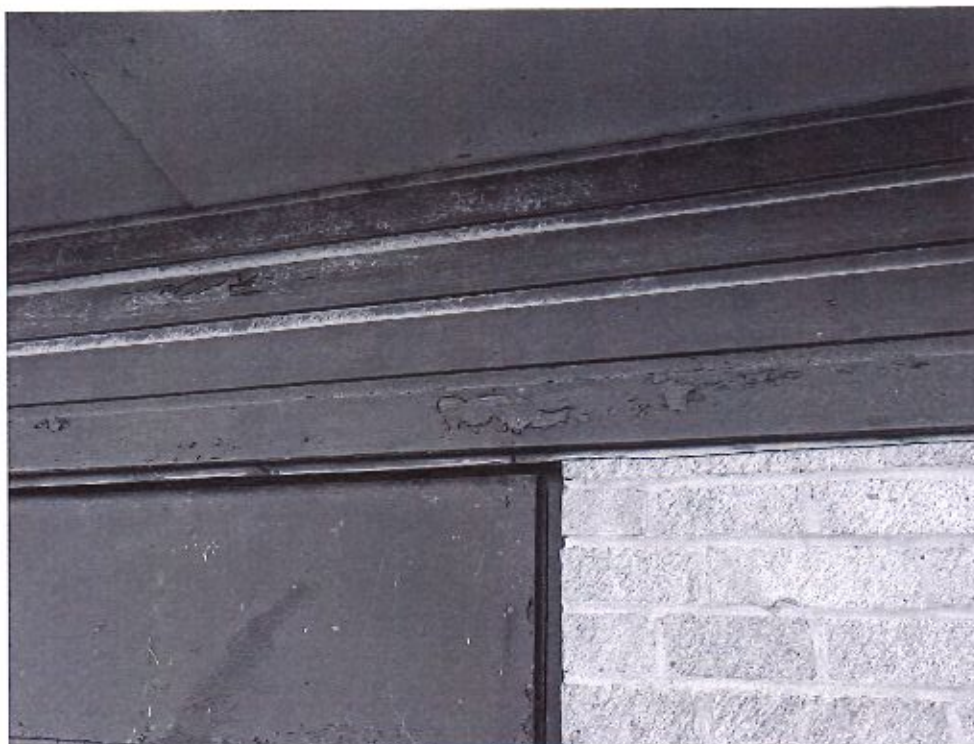
Photograph 103

External walls are in sound condition with only minor deterioration to some of the mortar pointing below the DPC level. The upper part of the walls are clad with timber weatherboard which is in sound condition however there is some breakdown of the protective coatings.

Fascia boards are of stained plywood and some decay and delamination of the board was noted.

Photograph:	External woodwork cladding and boarded over windows
Defect:	In need of repairs and redecoration. Soffits potentially an asbestos containing material

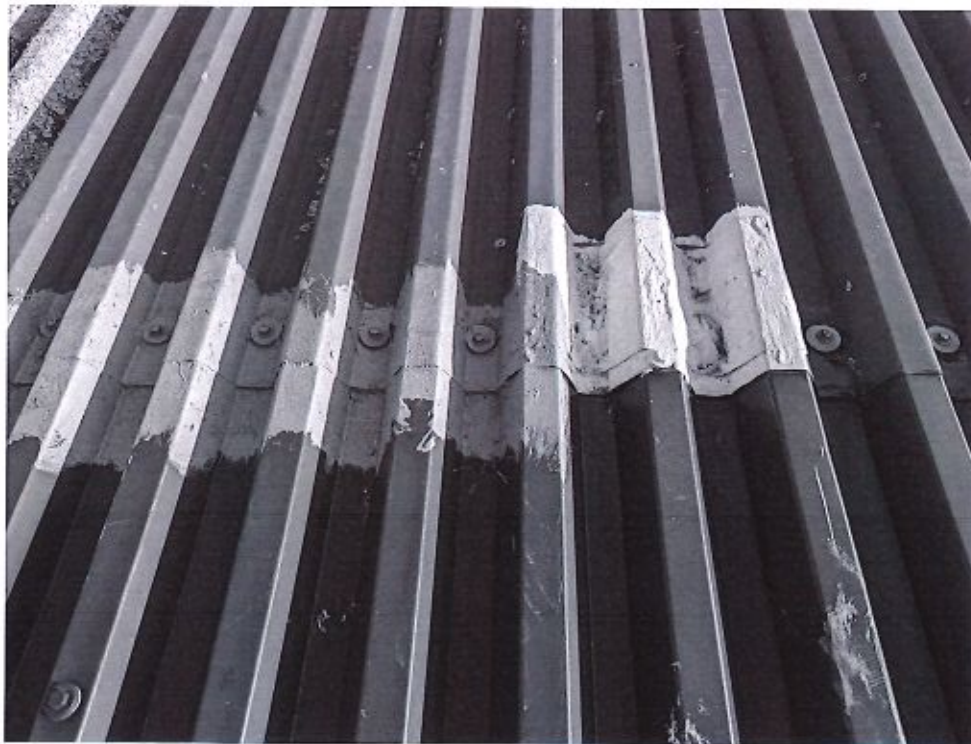
Photograph 110

Photograph:	Steel roof sheets
Defect:	Evidence of repairs to laps and fixings

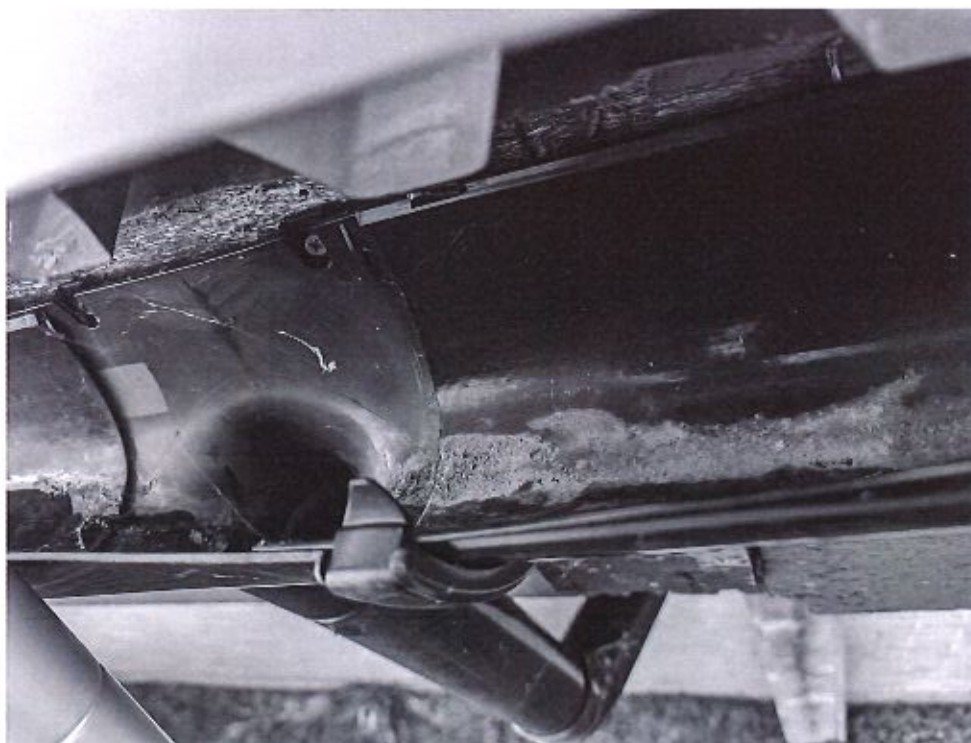
Photograph 112

damage noted to rainwater pipes and weed growth around gulleys, otherwise gutters appear to be working.

Photograph:	Plastic rainwater gutters and down pipes
Defect:	Some damage and deterioration to rainwater goods
