Refurbishment & Demolition Survey Report

Site Address: Maintenance & Community Hall Buildings at
Piddinghoe Sports Centre
Piddinghoe Lane
Peacehaven
BN10 8PF

Client Name: Lewes District Council

Survey Date: 17th January 2013

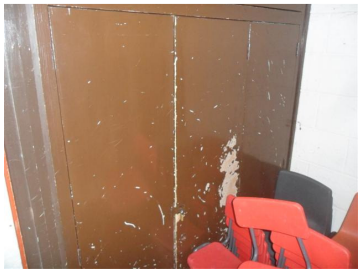
No access has been gained within the following locations:			
Building	Location	Comment	Image
Community Hall	Ground Floor Store – G19	No access within wood cupboards. Padlocked doors – no keys available

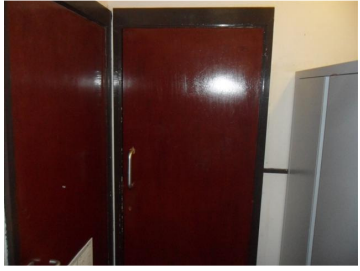
Community Hall	Ground Floor Store – G20	No access due to locked door – no key available

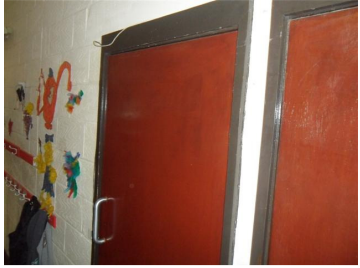
Community Hall	Ground Floor Void – G21	No access possible – no entry way	No photograph available
Community Hall	Ground Floor Store – G22	No access due to locked door – no key available

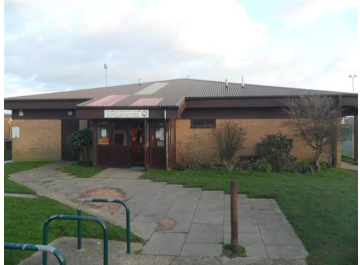
Limited access has been gained within the following locations:			
Buildings	Location	Comment	Image
All	All Locations	Limited access throughout as the buildings are still in use

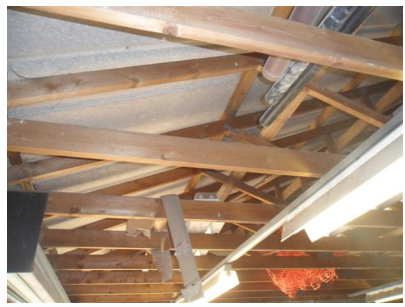
Floor	Room No.	Room Description	Material Risk Score (MRS)					Priority Risk Score (PRS)					Extent	Total Risk Score	Recommendations	
	Ground	G01	Workshop	Product 1-3	Treatment 0-3	Condition 0-3	Asbestos Type	Total MRS Score	Size of Area 0-3	Access 0-3	Disturbance 0-3	Maintenance 0-3	Total PRS Score	70m ²	11	REMOVE	✓
	Sample No.	Item Description												Risk Rating		ENCAPSULATE	
	Ref: 3	Cement roofing sheets		1	1	1	1	4	2	3	1	1	7	High		LABEL & MANAGE	
Additional Comments:

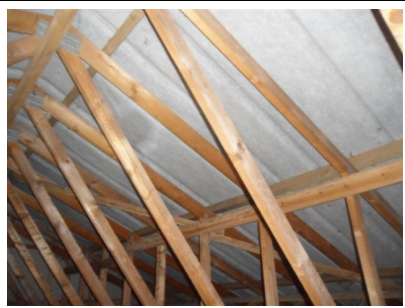
Floor	Room No.	Room Description	Material Risk Score (MRS)					Priority Risk Score (PRS)					Extent	Total Risk Score	Recommendations	
	Ground	G04	Ceiling Void	Product 1-3	Treatment 0-3	Condition 0-3	Asbestos Type	Total MRS Score	Size of Area 0-3	Access 0-3	Disturbance 0-3	Maintenance 0-3	Total PRS Score	50m ²	10	REMOVE	✓
	Sample No.	Item Description												Risk Rating		ENCAPSULATE	
	Ref: 3	Cement roofing sheets		1	1	1	1	4	3	1	1	1	6	Medium		LABEL & MANAGE	
Additional Comments:

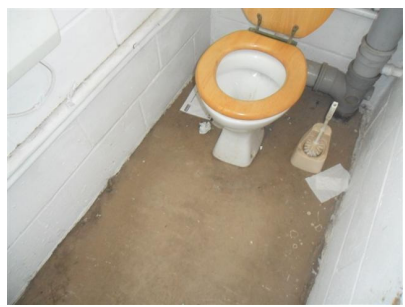
Floor	Room No.	Room Description	Material Risk Score (MRS)					Priority Risk Score (PRS)					Extent	Total Risk Score	Recommendations	
	Ground	G05	WC	Product 1-3	Treatment 0-3	Condition 0-3	Asbestos Type	Total MRS Score	Size of Area 0-3	Access 0-3	Disturbance 0-3	Maintenance 0-3	Total PRS Score			REMOVE	
	Sample No.	Item Description												Risk Rating		ENCAPSULATE	
	6	Floor lino					NADIS									LABEL & MANAGE	
Additional Comments:

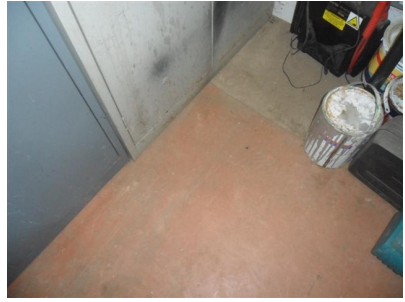
Floor	Room No.	Room Description	Material Risk Score (MRS)					Priority Risk Score (PRS)					Extent	Total Risk Score	Recommendations	
	Ground	G07	Store	Product 1-3	Treatment 0-3	Condition 0-3	Asbestos Type	Total MRS Score	Size of Area 0-3	Access 0-3	Disturbance 0-3	Maintenance 0-3	Total PRS Score			REMOVE	
	Sample No.	Item Description												Risk Rating		ENCAPSULATE	
	7	Floor lino					NADIS							Medium		LABEL & MANAGE	
Additional Comments:

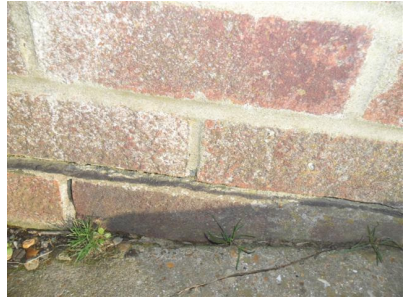
Floor	Room No.	Room Description	Material Risk Score (MRS)					Priority Risk Score (PRS)					Extent	Total Risk Score	Recommendations	
	Externals	EX01	All Elevations	Product 1-3	Treatment 0-3	Condition 0-3	Asbestos Type	Total MRS Score	Size of Area 0-3	Access 0-3	Disturbance 0-3	Maintenance 0-3	Total PRS Score			REMOVE	
	Sample No.	Item Description												Risk Rating		ENCAPSULATE	
	1	Damp proof course					NADIS							Medium		LABEL & MANAGE	
Additional Comments:

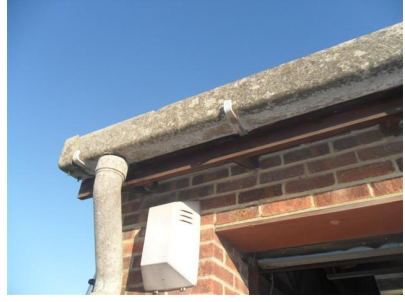
Floor	Room No.	Room Description	Material Risk Score (MRS)					Priority Risk Score (PRS)					Extent	Total Risk Score	Recommendations	
	Externals	EX01	All Elevations	Product 1-3	Treatment 0-3	Condition 0-3	Asbestos Type	Total MRS Score	Size of Area 0-3	Access 0-3	Disturbance 0-3	Maintenance 0-3	Total PRS Score	48 lm	9	REMOVE	✓
	Sample No.	Item Description												Risk Rating		ENCAPSULATE	
	2 & Ref: 2	Cement rainware		1	1	1	1	4	0	3	1	1	5	Medium		LABEL & MANAGE	
Additional Comments:

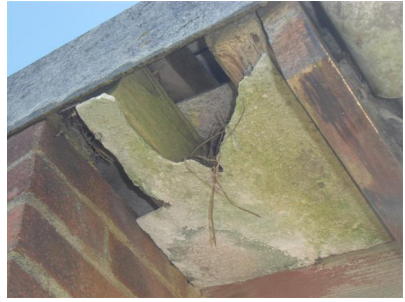
Floor	Room No.	Room Description	Material Risk Score (MRS)					Priority Risk Score (PRS)					Extent	Total Risk Score	Recommendations		
	Externals	EX01	All Elevations	Product 1-3	Treatment 0-3	Condition 0-3	Asbestos Type	Total MRS Score	Size of Area 0-3	Access 0-3	Disturbance 0-3	Maintenance 0-3	Total PRS Score			REMOVE		
	Sample No.	Item Description												Risk Rating		ENCAPSULATE		
	4 & Ref: 4	Soffit & fascia panels					NADIS							Medium		LABEL & MANAGE		
Additional Comments:

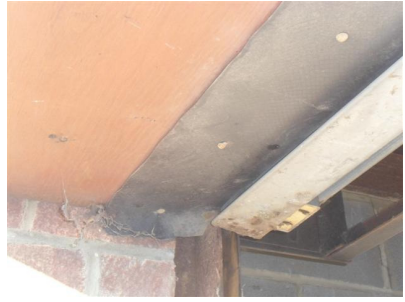
Floor	Room No.	Room Description	Material Risk Score (MRS)					Priority Risk Score (PRS)					Extent	Total Risk Score	Recommendations		
	Externals	EX01	All Elevations	Product 1-3	Treatment 0-3	Condition 0-3	Asbestos Type	Total MRS Score	Size of Area 0-3	Access 0-3	Disturbance 0-3	Maintenance 0-3	Total PRS Score			REMOVE		
	Sample No.	Item Description												Risk Rating		ENCAPSULATE		
	5	Felt to roller shutter					NADIS							Medium		LABEL & MANAGE		
Additional Comments:

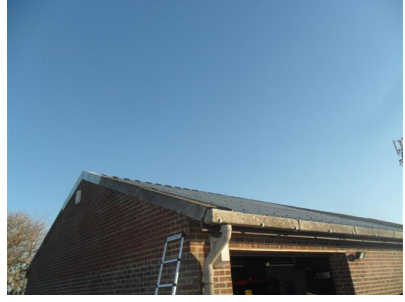
Floor	Room No.	Room Description	Material Risk Score (MRS)					Priority Risk Score (PRS)					Extent	Total Risk Score	Recommendations		
	Externals	R01	Roof	Product 1-3	Treatment 0-3	Condition 0-3	Asbestos Type	Total MRS Score	Size of Area 0-3	Access 0-3	Disturbance 0-3	Maintenance 0-3	Total PRS Score	300m ²	7	REMOVE	✓	
	Sample No.	Item Description												Risk Rating		ENCAPSULATE		
	3	Cement roofing sheets & fascias		1	1	1	1	4	0	1	1	1	3	Medium		LABEL & MANAGE		
Additional Comments:

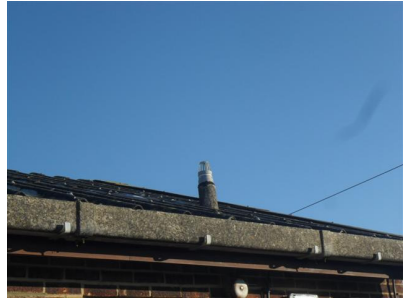
Floor	Room No.	Room Description	Material Risk Score (MRS)					Priority Risk Score (PRS)					Extent	Total Risk Score	Recommendations	
	Externals	R01	Roof	Product 1-3	Treatment 0-3	Condition 0-3	Asbestos Type	Total MRS Score	Size of Area 0-3	Access 0-3	Disturbance 0-3	Maintenance 0-3	Total PRS Score	1 Im	7	REMOVE	✓
	Sample No.	Item Description												Risk Rating		ENCAPSULATE	
V01	Cement flue pipe		1	1	1	1	4	0	1	1	1	3	Medium		LABEL & MANAGE		
Additional Comments: Presumed to contain asbestos.

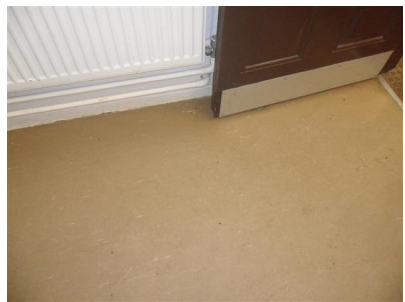
Floor	Room No.	Room Description	Material Risk Score (MRS)					Priority Risk Score (PRS)					Extent	Total Risk Score	Recommendations	
	Ground	G01	Changing Room	Product 1-3	Treatment 0-3	Condition 0-3	Asbestos Type	Total MRS Score	Size of Area 0-3	Access 0-3	Disturbance 0-3	Maintenance 0-3	Total PRS Score			REMOVE	
	Sample No.	Item Description												Risk Rating		ENCAPSULATE	
14	Floor lino					NADIS									LABEL & MANAGE		
Additional Comments:

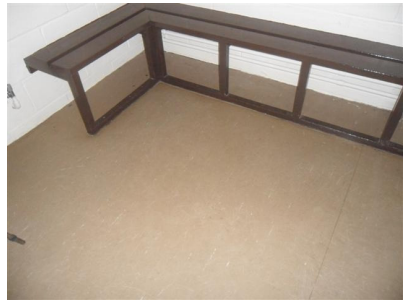
Floor	Room No.	Room Description	Material Risk Score (MRS)					Priority Risk Score (PRS)					Extent	Total Risk Score	Recommendations	
	Ground	G02	Changing Room	Product 1-3	Treatment 0-3	Condition 0-3	Asbestos Type	Total MRS Score	Size of Area 0-3	Access 0-3	Disturbance 0-3	Maintenance 0-3	Total PRS Score			REMOVE	
	Sample No.	Item Description												Risk Rating		ENCAPSULATE	
Ref: 14	Floor lino					NADIS									LABEL & MANAGE		
Additional Comments:

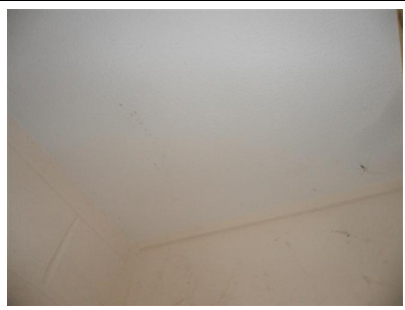
Floor	Room No.	Room Description	Material Risk Score (MRS)					Priority Risk Score (PRS)					Extent	Total Risk Score	Recommendations	
	Ground	G03	Cupboard	Product 1-3	Treatment 0-3	Condition 0-3	Asbestos Type	Total MRS Score	Size of Area 0-3	Access 0-3	Disturbance 0-3	Maintenance 0-3	Total PRS Score			REMOVE	
	Sample No.	Item Description												Risk Rating		ENCAPSULATE	
	Ref: 15	Textured coating to ceiling					NADIS									LABEL & MANAGE	
Additional Comments:

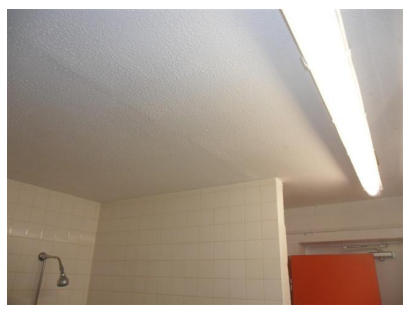
Floor	Room No.	Room Description	Material Risk Score (MRS)					Priority Risk Score (PRS)					Extent	Total Risk Score	Recommendations	
	Ground	G04	Showers & WC	Product 1-3	Treatment 0-3	Condition 0-3	Asbestos Type	Total MRS Score	Size of Area 0-3	Access 0-3	Disturbance 0-3	Maintenance 0-3	Total PRS Score			REMOVE	
	Sample No.	Item Description												Risk Rating		ENCAPSULATE	
	15	Textured coating to ceiling					NADIS									LABEL & MANAGE	
Additional Comments:

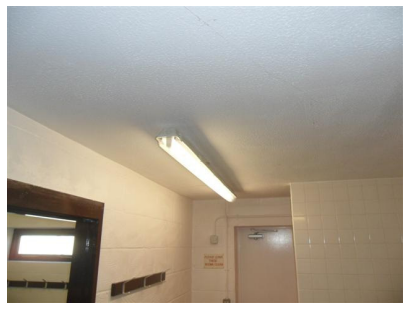
Floor	Room No.	Room Description	Material Risk Score (MRS)					Priority Risk Score (PRS)					Extent	Total Risk Score	Recommendations	
	Ground	G06	Showers & WC	Product 1-3	Treatment 0-3	Condition 0-3	Asbestos Type	Total MRS Score	Size of Area 0-3	Access 0-3	Disturbance 0-3	Maintenance 0-3	Total PRS Score			REMOVE	
	Sample No.	Item Description												Risk Rating		ENCAPSULATE	
	Ref: 15	Textured coating to ceiling					NADIS									LABEL & MANAGE	
Additional Comments:

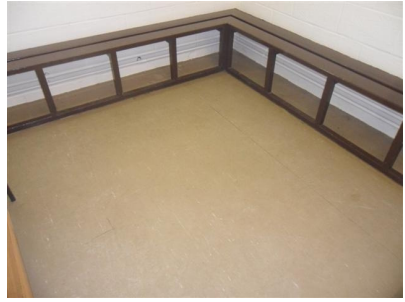
Floor	Room No.	Room Description	Material Risk Score (MRS)					Priority Risk Score (PRS)					Extent	Total Risk Score	Recommendations	
	Ground	G07	Changing Room	Product 1-3	Treatment 0-3	Condition 0-3	Asbestos Type	Total MRS Score	Size of Area 0-3	Access 0-3	Disturbance 0-3	Maintenance 0-3	Total PRS Score			REMOVE	
	Sample No.	Item Description												Risk Rating		ENCAPSULATE	
	Ref: 14	Floor lino					NADIS									LABEL & MANAGE	
Additional Comments:

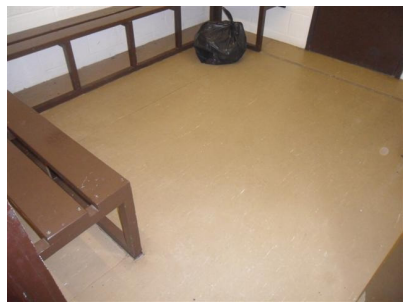
Floor	Room No.	Room Description	Material Risk Score (MRS)					Priority Risk Score (PRS)					Extent	Total Risk Score	Recommendations	
	Ground	G08	Changing Room	Product 1-3	Treatment 0-3	Condition 0-3	Asbestos Type	Total MRS Score	Size of Area 0-3	Access 0-3	Disturbance 0-3	Maintenance 0-3	Total PRS Score			REMOVE	
	Sample No.	Item Description												Risk Rating		ENCAPSULATE	
	Ref: 14	Floor lino					NADIS									LABEL & MANAGE	
Additional Comments:

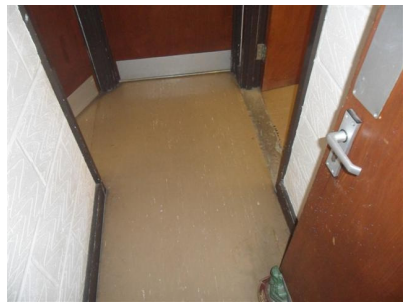
Floor	Room No.	Room Description	Material Risk Score (MRS)					Priority Risk Score (PRS)					Extent	Total Risk Score	Recommendations	
	Ground	G10	Lobby	Product 1-3	Treatment 0-3	Condition 0-3	Asbestos Type	Total MRS Score	Size of Area 0-3	Access 0-3	Disturbance 0-3	Maintenance 0-3	Total PRS Score			REMOVE	
	Sample No.	Item Description												Risk Rating		ENCAPSULATE	
	Ref: 14	Floor lino					NADIS									LABEL & MANAGE	
Additional Comments:

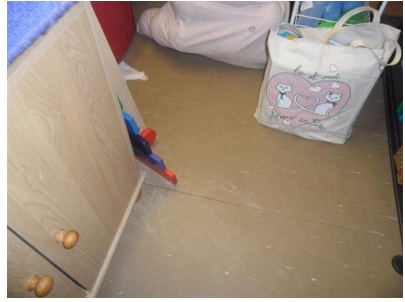
Floor	Room No.	Room Description	Material Risk Score (MRS)					Priority Risk Score (PRS)					Extent	Total Risk Score	Recommendations	
	Ground	G11	Reception	Product 1-3	Treatment 0-3	Condition 0-3	Asbestos Type	Total MRS Score	Size of Area 0-3	Access 0-3	Disturbance 0-3	Maintenance 0-3	Total PRS Score	Risk Rating		REMOVE	
	Sample No.	Item Description														ENCAPSULATE	
Ref: 14	Floor lino					NADIS									LABEL & MANAGE		
Additional Comments:

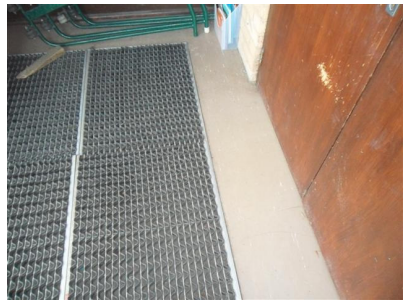
Floor	Room No.	Room Description	Material Risk Score (MRS)					Priority Risk Score (PRS)					Extent	Total Risk Score	Recommendations	
	Ground	G12	Entrance	Product 1-3	Treatment 0-3	Condition 0-3	Asbestos Type	Total MRS Score	Size of Area 0-3	Access 0-3	Disturbance 0-3	Maintenance 0-3	Total PRS Score	Risk Rating		REMOVE	
	Sample No.	Item Description														ENCAPSULATE	
Ref: 14	Floor lino					NADIS									LABEL & MANAGE		
Additional Comments:

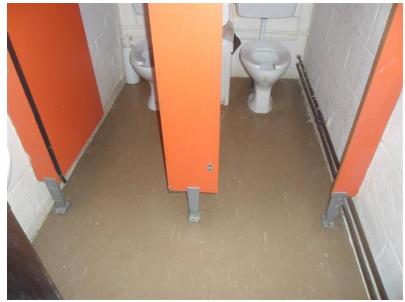
Floor	Room No.	Room Description	Material Risk Score (MRS)					Priority Risk Score (PRS)					Extent	Total Risk Score	Recommendations	
	Ground	G13	Female WC's	Product 1-3	Treatment 0-3	Condition 0-3	Asbestos Type	Total MRS Score	Size of Area 0-3	Access 0-3	Disturbance 0-3	Maintenance 0-3	Total PRS Score	Risk Rating		REMOVE	
	Sample No.	Item Description														ENCAPSULATE	
Ref: 14	Floor lino					NADIS									LABEL & MANAGE		
Additional Comments:

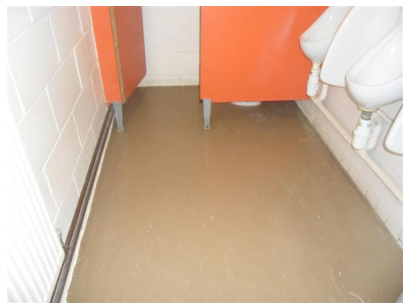
Floor	Room No.	Room Description	Material Risk Score (MRS)					Priority Risk Score (PRS)					Extent	Total Risk Score	Recommendations	
	Ground	G14	Male WC's	Product 1-3	Treatment 0-3	Condition 0-3	Asbestos Type	Total MRS Score	Size of Area 0-3	Access 0-3	Disturbance 0-3	Maintenance 0-3	Total PRS Score			REMOVE	
	Sample No.	Item Description															
	Ref: 14	Floor lino					NADIS									LABEL & MANAGE	
Additional Comments:

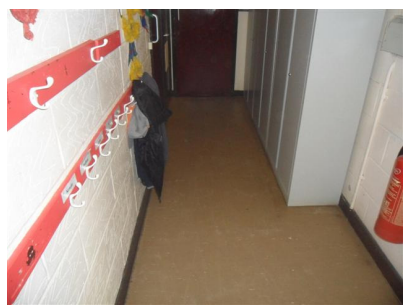
Floor	Room No.	Room Description	Material Risk Score (MRS)					Priority Risk Score (PRS)					Extent	Total Risk Score	Recommendations	
	Ground	G15	Corridor	Product 1-3	Treatment 0-3	Condition 0-3	Asbestos Type	Total MRS Score	Size of Area 0-3	Access 0-3	Disturbance 0-3	Maintenance 0-3	Total PRS Score			REMOVE	
	Sample No.	Item Description															
	Ref: 14	Floor lino					NADIS									LABEL & MANAGE	
Additional Comments:

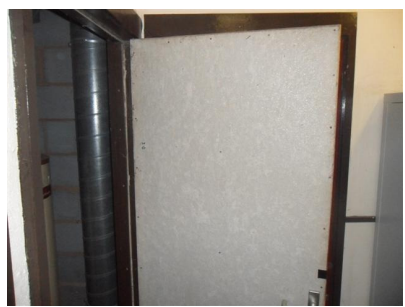
Floor	Room No.	Room Description	Material Risk Score (MRS)					Priority Risk Score (PRS)					Extent	Total Risk Score	Recommendations	
	Ground	G16	Cylinder Room	Product 1-3	Treatment 0-3	Condition 0-3	Asbestos Type	Total MRS Score	Size of Area 0-3	Access 0-3	Disturbance 0-3	Maintenance 0-3	Total PRS Score			REMOVE	
	Sample No.	Item Description															
	16	Panel to back of door					NADIS									LABEL & MANAGE	
Additional Comments:

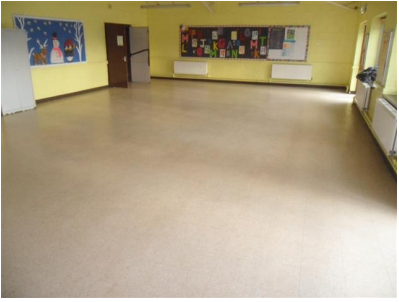
Ground	G17	Function Room	Product 1-3	Treatment 0-3	Condition 0-3	Asbestos Type	Total MRS Score	Size of Area 0-3	Access 0-3	Disturbance 0-3	Maintenance 0-3	Total PRS Score	Risk Rating		REMOVE	
	Sample No.	Item Description					NADIS									ENCAPSULATE	
17	Floor tiles					NADIS									LABEL & MANAGE		
Additional Comments:

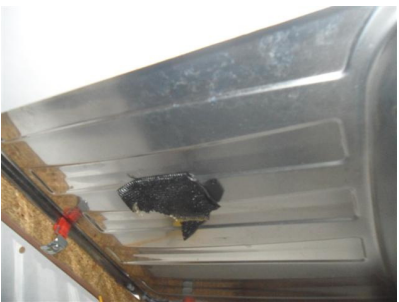
Ground	G17	Function Room	Product 1-3	Treatment 0-3	Condition 0-3	Asbestos Type	Total MRS Score	Size of Area 0-3	Access 0-3	Disturbance 0-3	Maintenance 0-3	Total PRS Score	Risk Rating		REMOVE	
	Sample No.	Item Description					NADIS									ENCAPSULATE	
18	Sink pad					NADIS									LABEL & MANAGE		
Additional Comments:

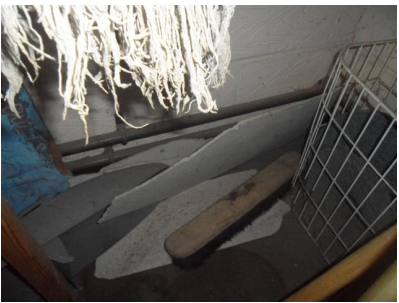
Ground	G18	Boiler Room	Product 1-3	Treatment 0-3	Condition 0-3	Asbestos Type	Total MRS Score	Size of Area 0-3	Access 0-3	Disturbance 0-3	Maintenance 0-3	Total PRS Score	Risk Rating		REMOVE	
	Sample No.	Item Description					NADIS									ENCAPSULATE	
19	Loose panels & debris					NADIS									LABEL & MANAGE		
Additional Comments:

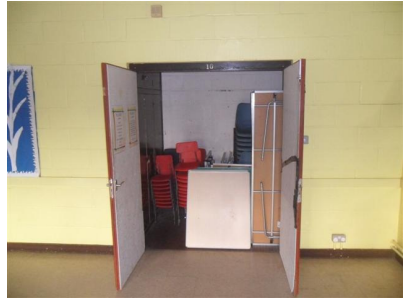
Floor	Room No.	Room Description	Material Risk Score (MRS)					Priority Risk Score (PRS)					Extent	Total Risk Score	Recommendations	
	Ground	G19	Store	Product 1-3	Treatment 0-3	Condition 0-3	Asbestos Type	Total MRS Score	Size of Area 0-3	Access 0-3	Disturbance 0-3	Maintenance 0-3	Total PRS Score	Risk Rating		REMOVE	
	Sample No.	Item Description					NADIS										
20	Panels to backs of doors					NADIS									LABEL & MANAGE		
Additional Comments:

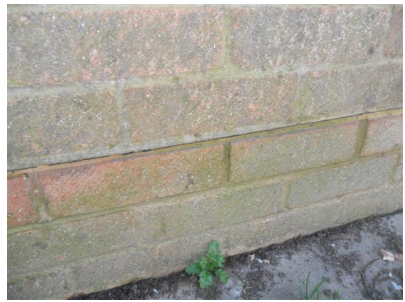
Floor	Room No.	Room Description	Material Risk Score (MRS)					Priority Risk Score (PRS)					Extent	Total Risk Score	Recommendations	
	Externals	EX01	All Elevations	Product 1-3	Treatment 0-3	Condition 0-3	Asbestos Type	Total MRS Score	Size of Area 0-3	Access 0-3	Disturbance 0-3	Maintenance 0-3	Total PRS Score	Risk Rating		REMOVE	
	Sample No.	Item Description					NADIS										
8	Damp proof course					NADIS									LABEL & MANAGE		
Additional Comments:

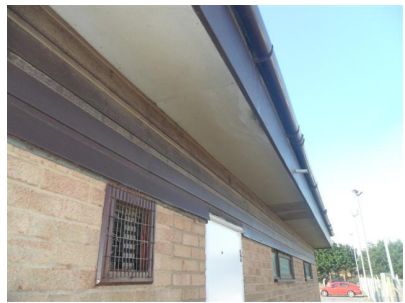
Floor	Room No.	Room Description	Material Risk Score (MRS)					Priority Risk Score (PRS)					Extent	Total Risk Score	Recommendations	
	Externals	EX01	All Elevations	Product 1-3	Treatment 0-3	Condition 0-3	Asbestos Type	Total MRS Score	Size of Area 0-3	Access 0-3	Disturbance 0-3	Maintenance 0-3	Total PRS Score	Risk Rating		REMOVE	
	Sample No.	Item Description					NADIS										
9 & Ref: 9	Soffit panels (some behind wood panels)					NADIS									LABEL & MANAGE		
Additional Comments:

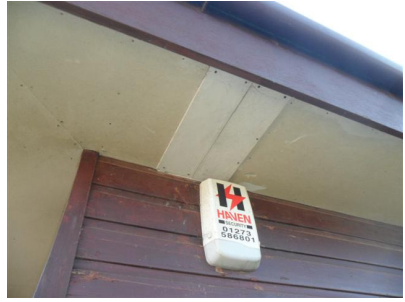
Floor	Room No.	Room Description	Material Risk Score (MRS)					Priority Risk Score (PRS)					Extent	Total Risk Score	Recommendations	
	Externals	EX01	All Elevations	Product 1-3	Treatment 0-3	Condition 0-3	Asbestos Type	Total MRS Score	Size of Area 0-3	Access 0-3	Disturbance 0-3	Maintenance 0-3	Total PRS Score			REMOVE	
	Sample No.	Item Description												Risk Rating		ENCAPSULATE	
10	Panel to soffit					NADIS									LABEL & MANAGE		
Additional Comments:

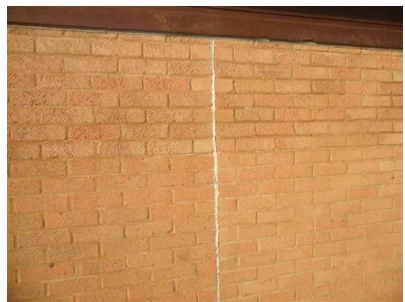
Floor	Room No.	Room Description	Material Risk Score (MRS)					Priority Risk Score (PRS)					Extent	Total Risk Score	Recommendations	
	Externals	EX01	All Elevations	Product 1-3	Treatment 0-3	Condition 0-3	Asbestos Type	Total MRS Score	Size of Area 0-3	Access 0-3	Disturbance 0-3	Maintenance 0-3	Total PRS Score			REMOVE	
	Sample No.	Item Description												Risk Rating		ENCAPSULATE	
11	Putty to wall					NADIS									LABEL & MANAGE		
Additional Comments:

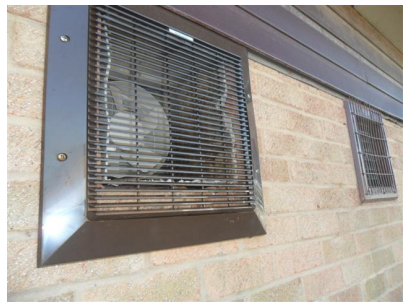
Floor	Room No.	Room Description	Material Risk Score (MRS)					Priority Risk Score (PRS)					Extent	Total Risk Score	Recommendations	
	Externals	EX01	All Elevations	Product 1-3	Treatment 0-3	Condition 0-3	Asbestos Type	Total MRS Score	Size of Area 0-3	Access 0-3	Disturbance 0-3	Maintenance 0-3	Total PRS Score			REMOVE	
	Sample No.	Item Description												Risk Rating		ENCAPSULATE	
12 & Ref: 12	Vent surrounds X2					NADIS									LABEL & MANAGE		
Additional Comments:

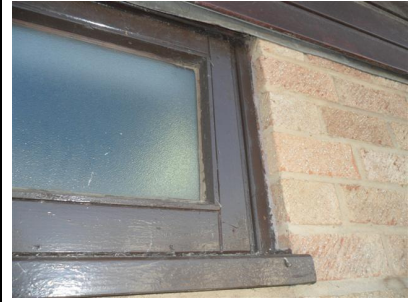
core		Community Hall Building														
Floor	Room No.	Room Description	Material Risk Score (MRS)					Priority Risk Score (PRS)					Extent	Total Risk Score	Recommendations	
Externals	EX01	All Elevations	Product 1-3	Treatment 0-3	Condition 0-3	Asbestos Type	Total MRS Score	Size of Area 0-3	Access 0-3	Disturbance 0-3	Maintenance 0-3	Total PRS Score			REMOVE	
Sample No.	Item Description												Risk Rating		ENCAPSULATE	
13 & Ref: 13	Putty around windows and door					NADIS									LABEL & MANAGE	
Additional Comments:
