### **AGENDA**

**DRAFT Minutes of the Community House Sub-Committee held in the Anzac Room, Community House on Monday 20<sup>th</sup> November at 7.30pm**

**MANAGEMENT SURVEY  
TO IDENTIFY ASBESTOS PRODUCTS AT**

**Peacehaven Town Council  
Community House  
Meridian Centre  
Peacehaven  
BN10 8BB  
SURVEY REFERENCE NO.  
ENV1038**

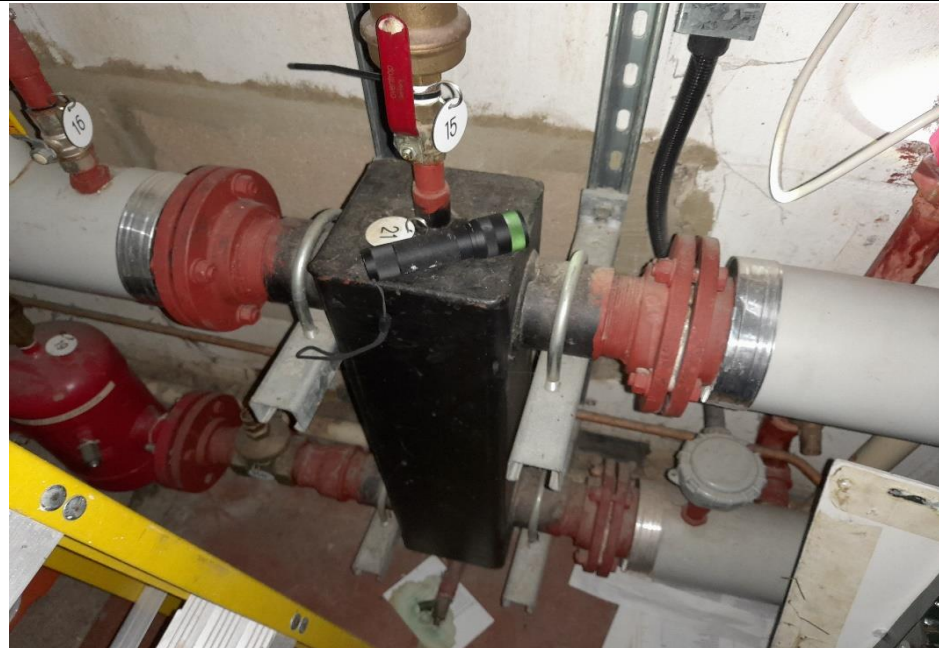
Photo Number:	1
Sample Number:	1
Material Type:	Gaskets
Level of Identification:	Asbestos not detected
Location / Description:

G/012 Boiler room - To pipes

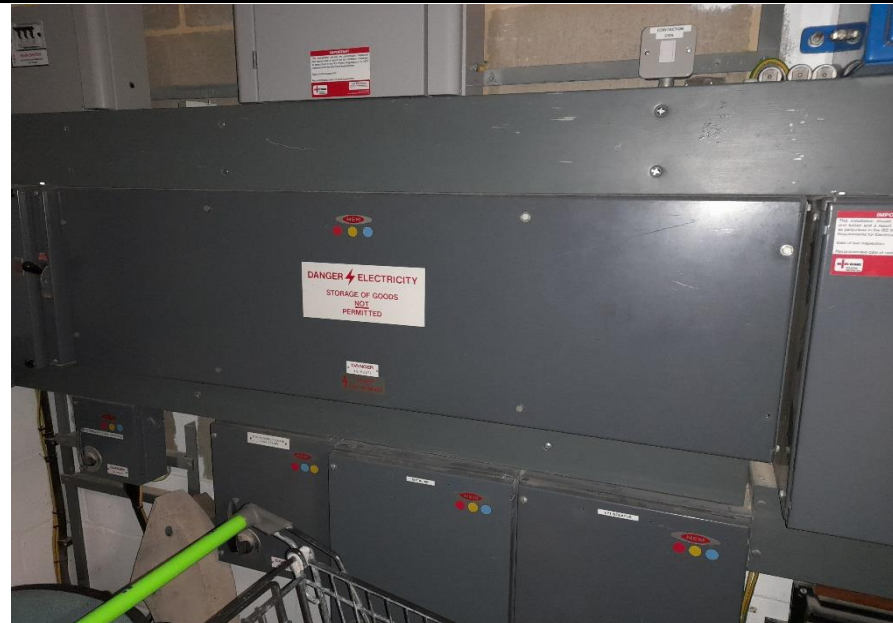
Photo Number:	2
Sample Number:	
Material Type:	
Level of Identification:	Presumed
Location / Description:

- 8.2 All listed inaccessible items/areas should be presumed to contain asbestos materials until further investigations can be carried out to confirm or refute the presence of asbestos.

G/021 Electrical intake room - Live switch boxes not accessed

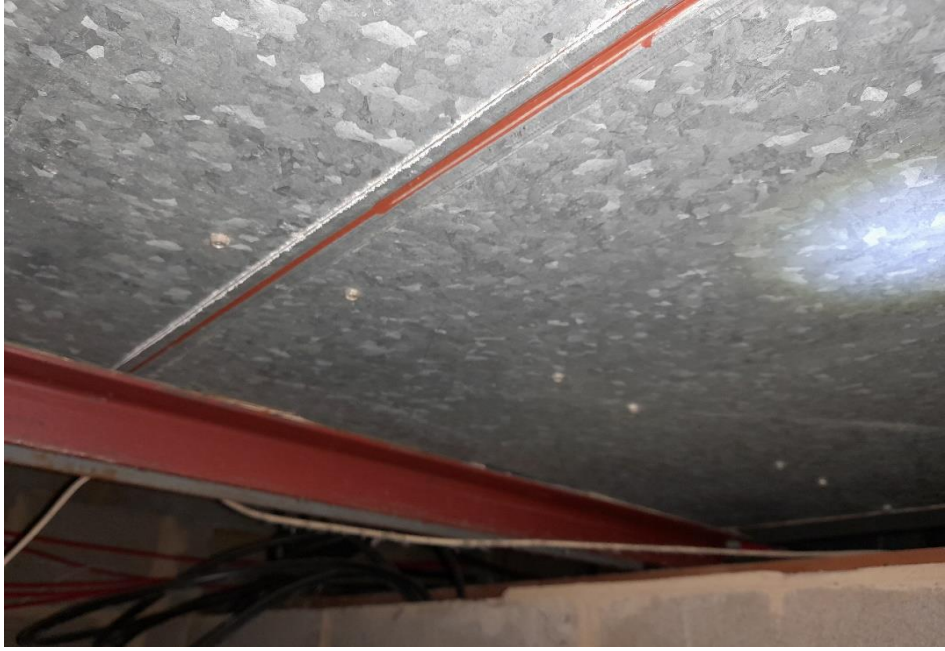
Photo Number:	3

Sample Number:	2	
Material Type:	Mastic	
Level of Identification:	Asbestos not detected	
Location / Description:	G/022 Store - To ducting above ceiling	
Photo Number:	4

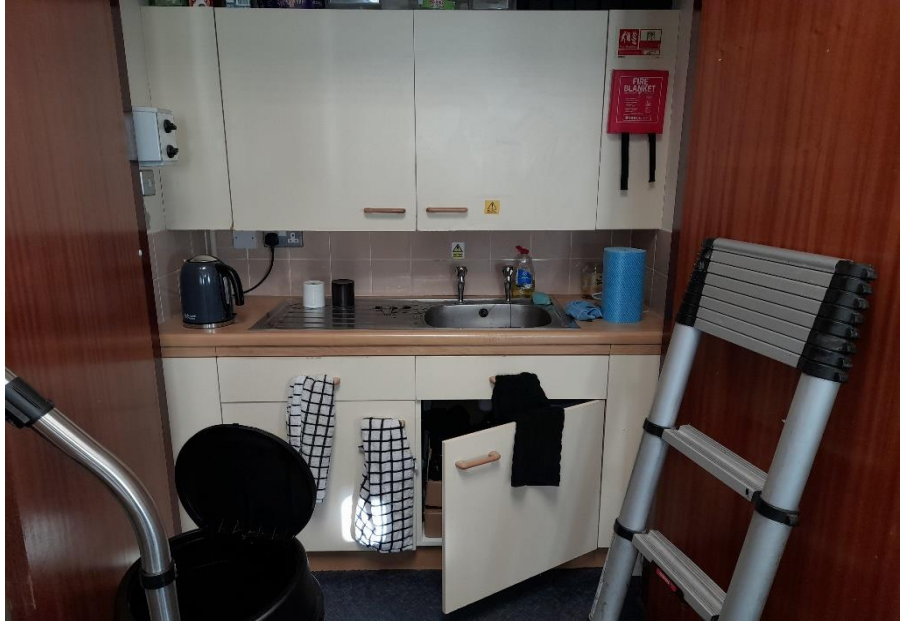
Sample Number:	3	
Material Type:	Bitumen	
Level of Identification:	Asbestos not detected	
Location / Description:	G/030 Kitchenette - Sink pad

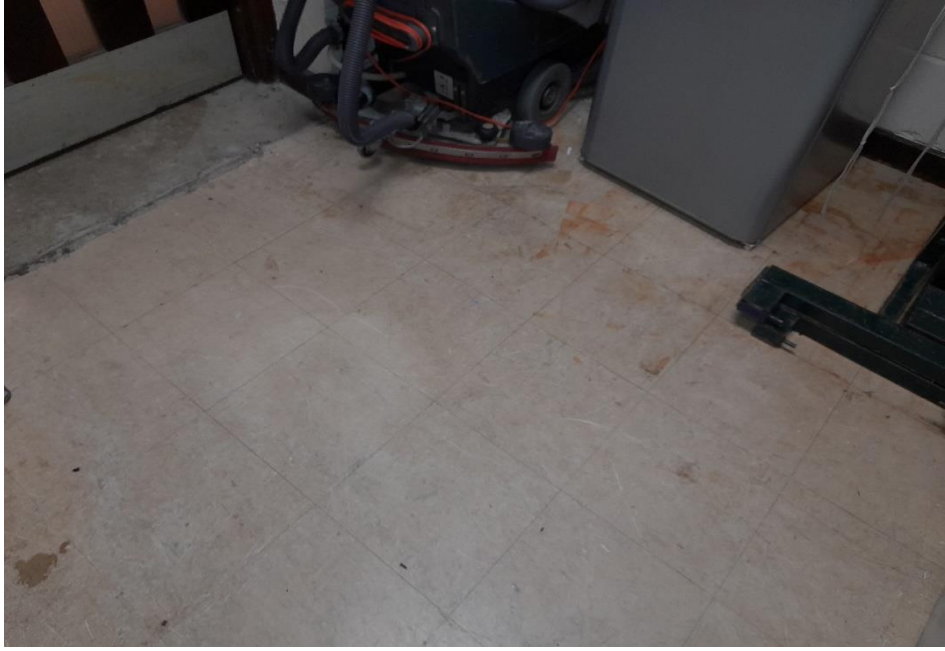
Photo Number:	5

Sample Number:	4	
Material Type:	Floor tile	
Level of Identification:	Asbestos not detected	
Location / Description:	G/040 Store - Floor	
Photo Number:	6

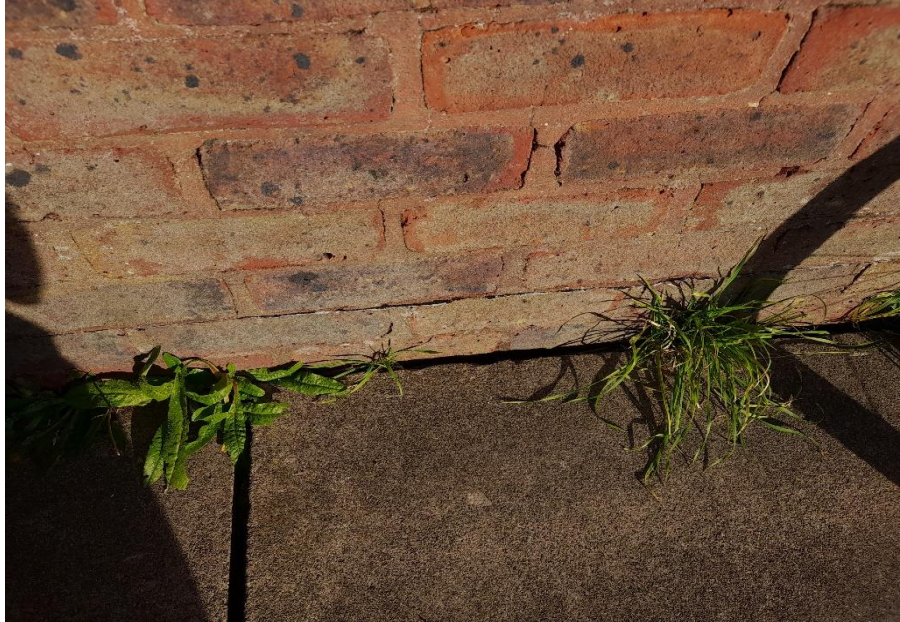
6.4.1 The external low level damp proof course was sampled and analysis confirmed that Chrysotile (White) asbestos was present.

Sample Number:	5	
Material Type:	Bitumen	
Level of Identification:	Identified	
Location / Description:	External Low level - Damp proof course

- 8.1 The asbestos containing damp proof course was in a fair condition and can remain in situ. If this material is likely to be significantly disturbed, it should be removed under controlled conditions and disposed of in accordance with Hazardous Waste Regulations (2005). This is not a licensed activity but the Control of Asbestos Regulations (2012) must still be adhered to. For further guidance on removal please see <http://www.hse.gov.uk/asbestos/essentials/>.
