DRAFT Minutes of the meeting of the Leisure, Amenities & Environment Committee held at Community House on Tuesday 9th January 2024 at 7.30pm

Property Condition Report

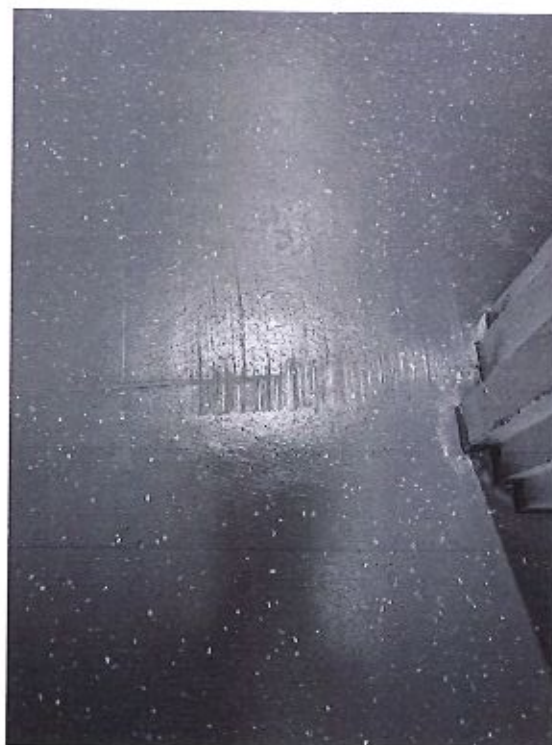
Photograph 14

Photograph:	Accessible WC doorway
Defect:	Door binding on floor, in need of easing or adjustment

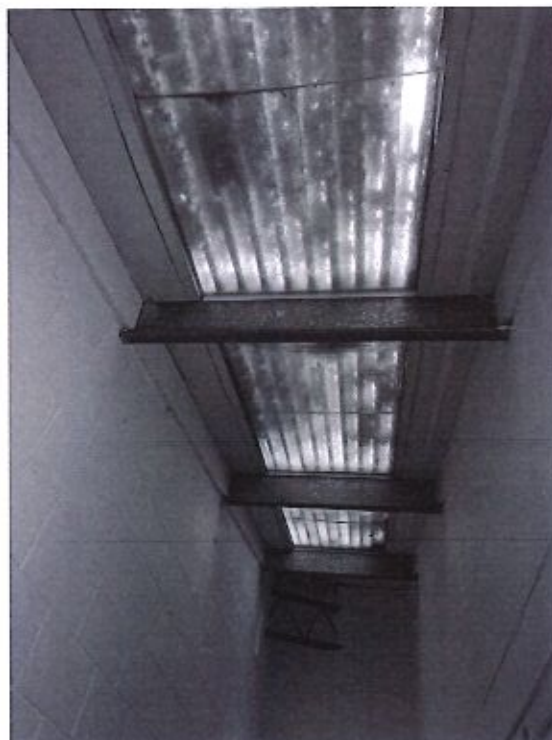
Photograph 16

Photograph:	Corridor rooflights
Defect:	Heavily discoloured

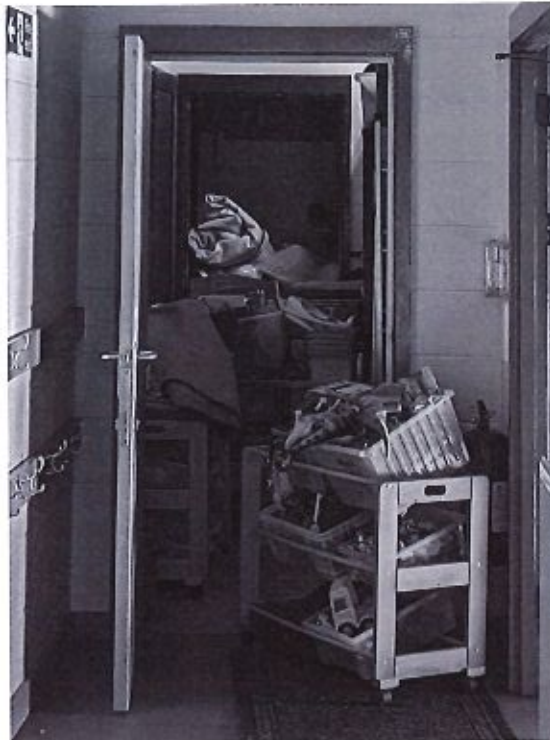
Photograph 19

Photograph:	General view
Defect:	Inspection limited due to the amount of stored items

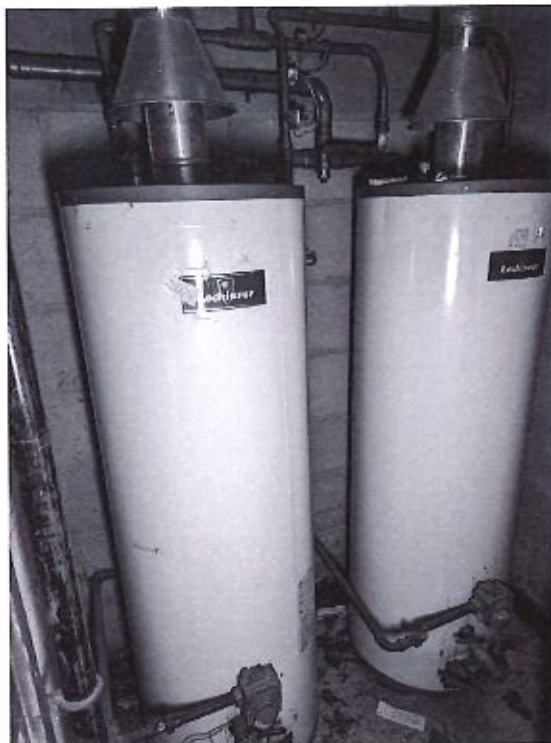
Photograph 23

Photograph:	Gas fired water heaters accessed off storage room
Defect:	R/H heater appears disconnected, L/H assumed to be working

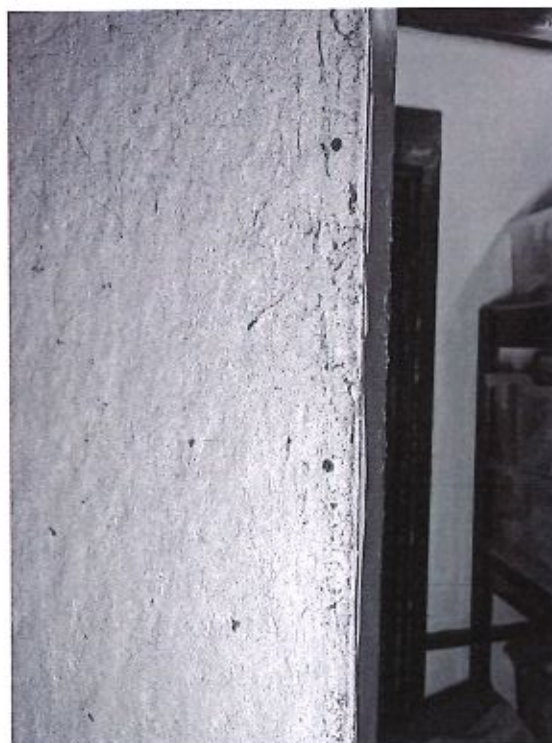
Photograph 24

Photograph:	Rear of door to water heater cupboard
Defect:	Door faced with insulation material possibly containing asbestos

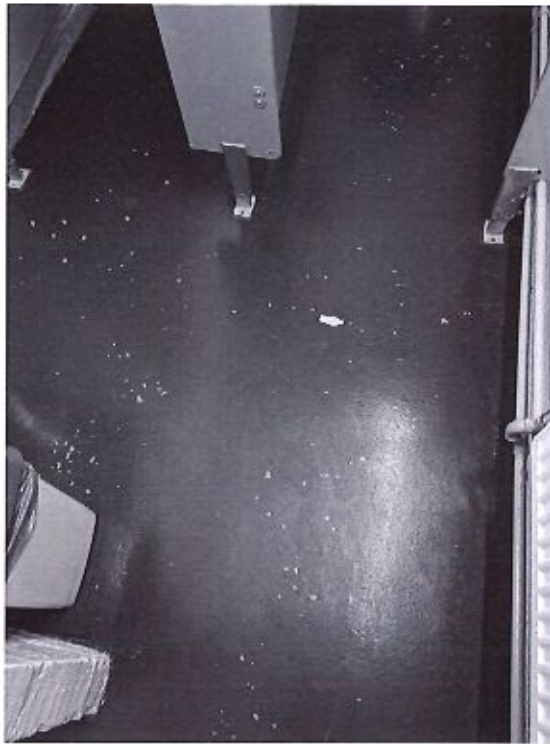
Photograph 33

Photograph:	Floor female WC
Defect:	Painted floor finish marked and damaged

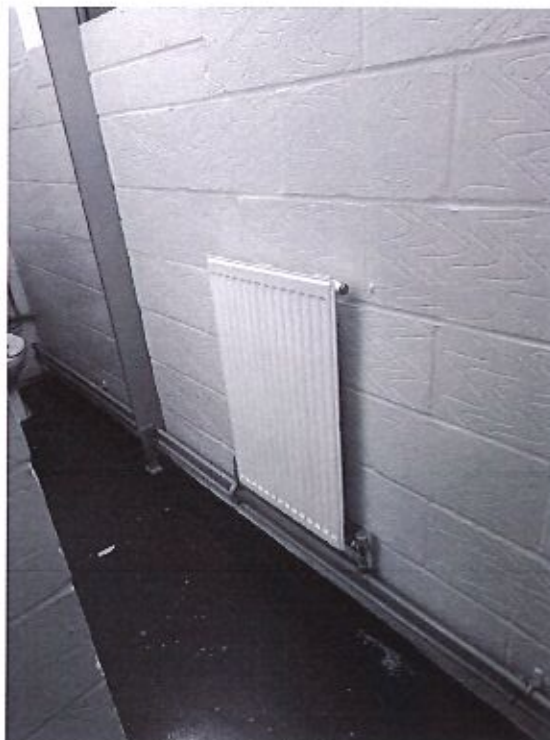
Photograph 34

Photograph:	Radiator female WC
Defect:

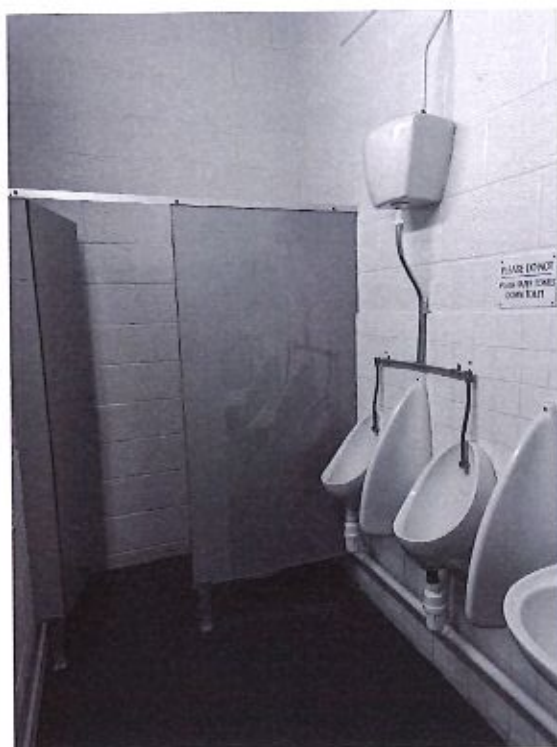
Photograph 35

Photograph:	General view
Defect:

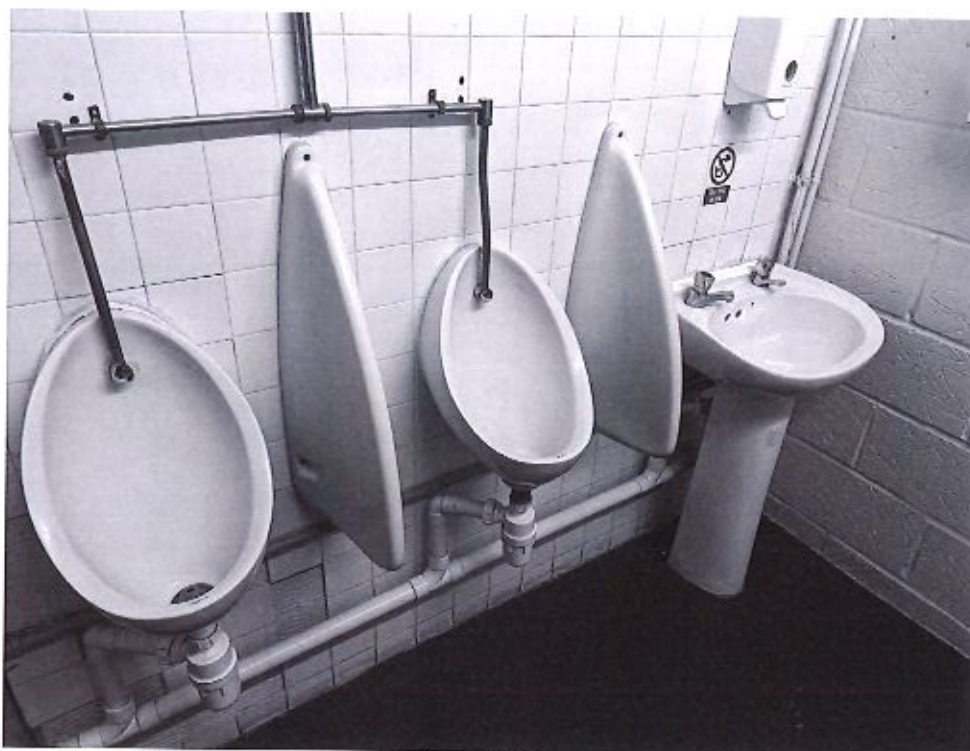
Photograph 37

Photograph:	Urinals
Defect:

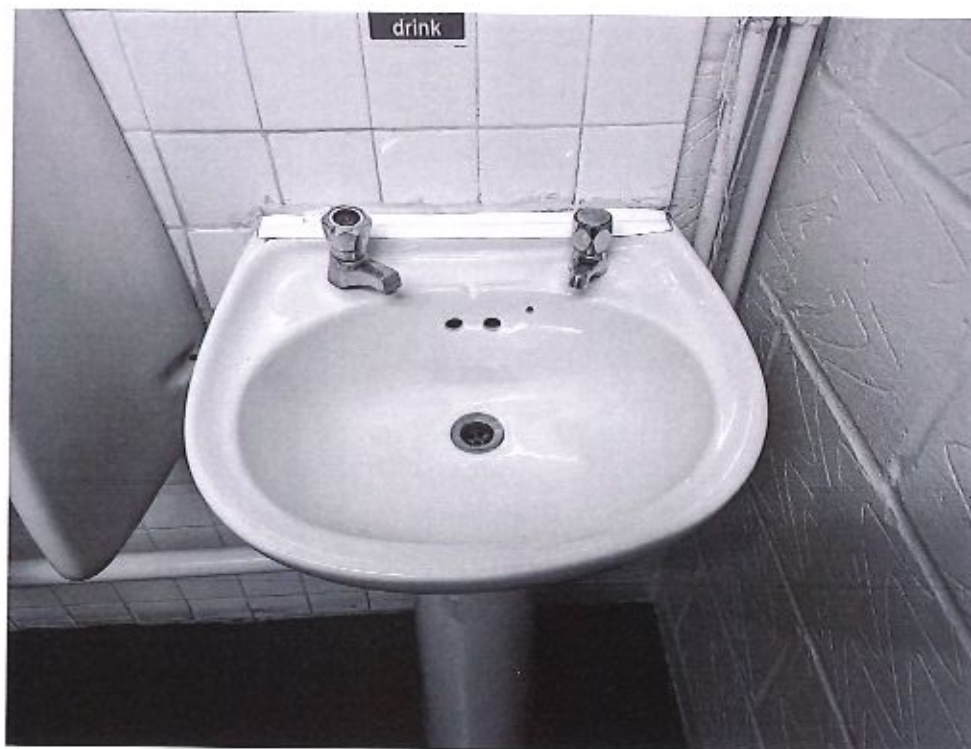
Photograph 38

Photograph:	Basin
Defect:

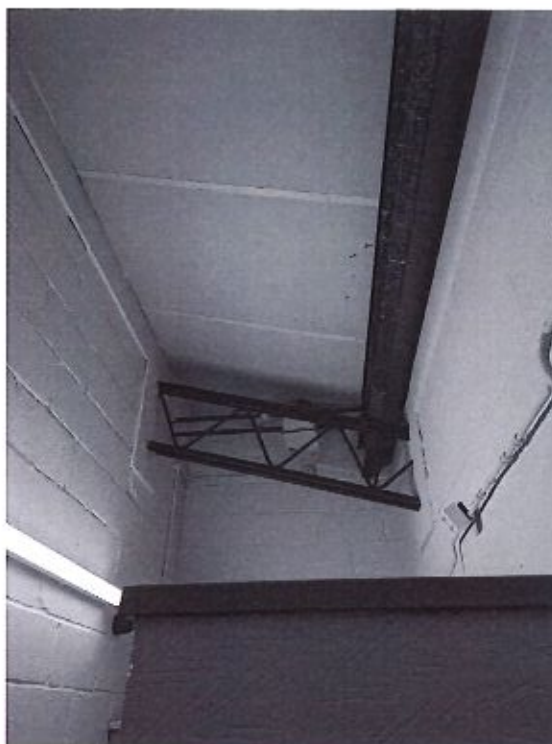
Photograph 39

Photograph:	Ceiling male WC
Defect:

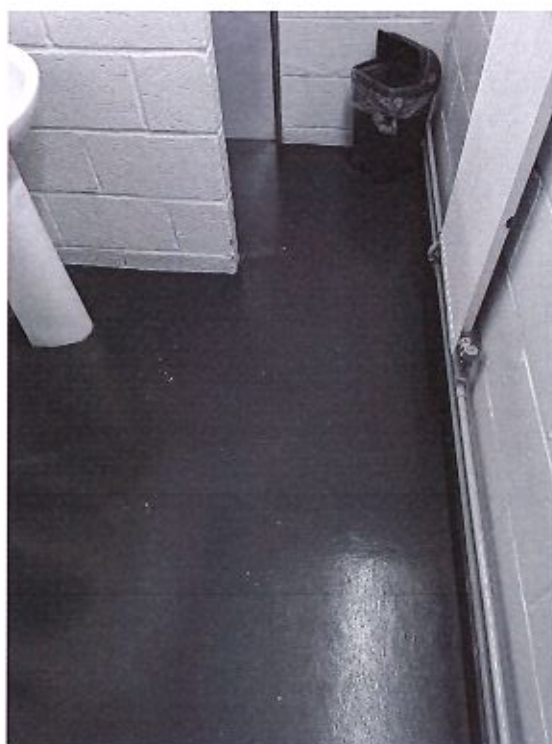
Photograph 40

Photograph:	Floor male WC
Defect:

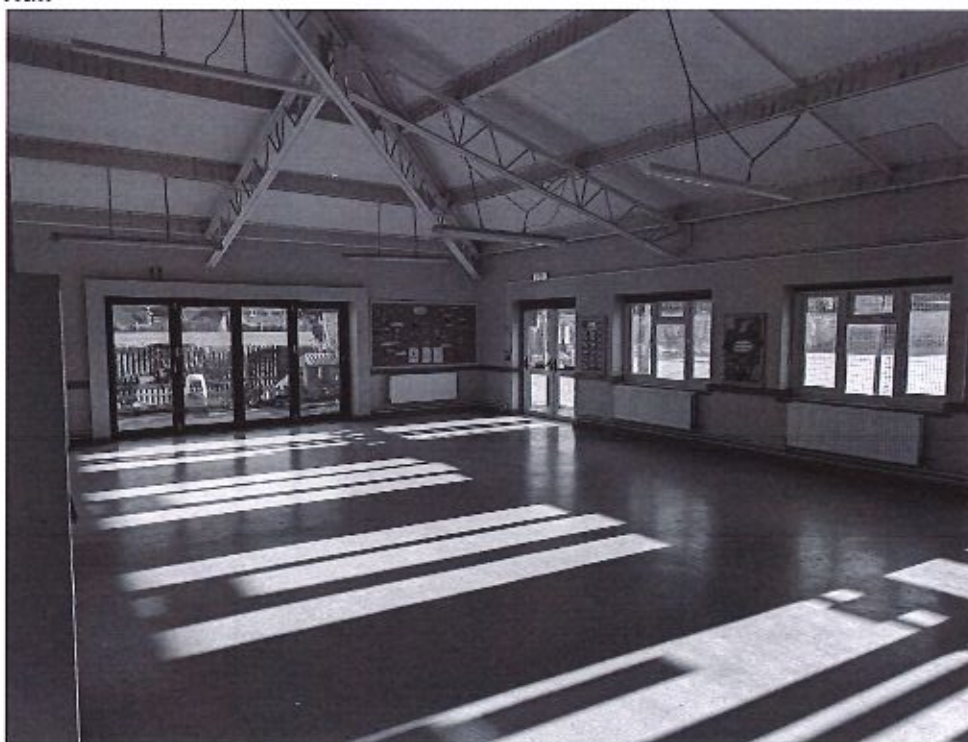
Photograph 42

Photograph:	General view
Defect:

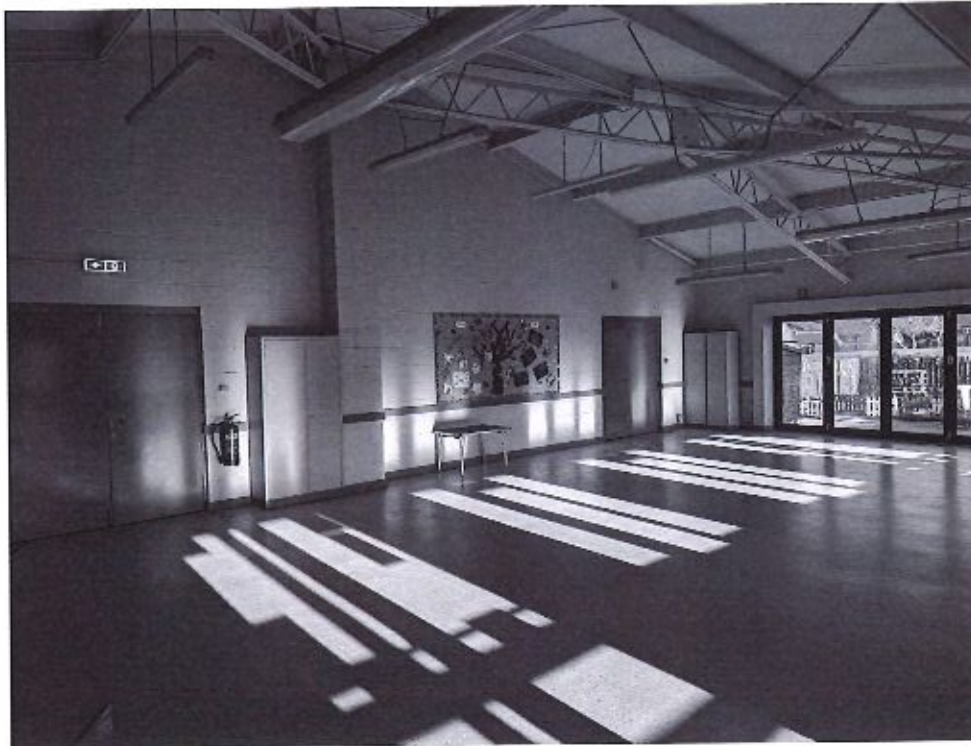
Photograph 43

Photograph:	General view
Defect:

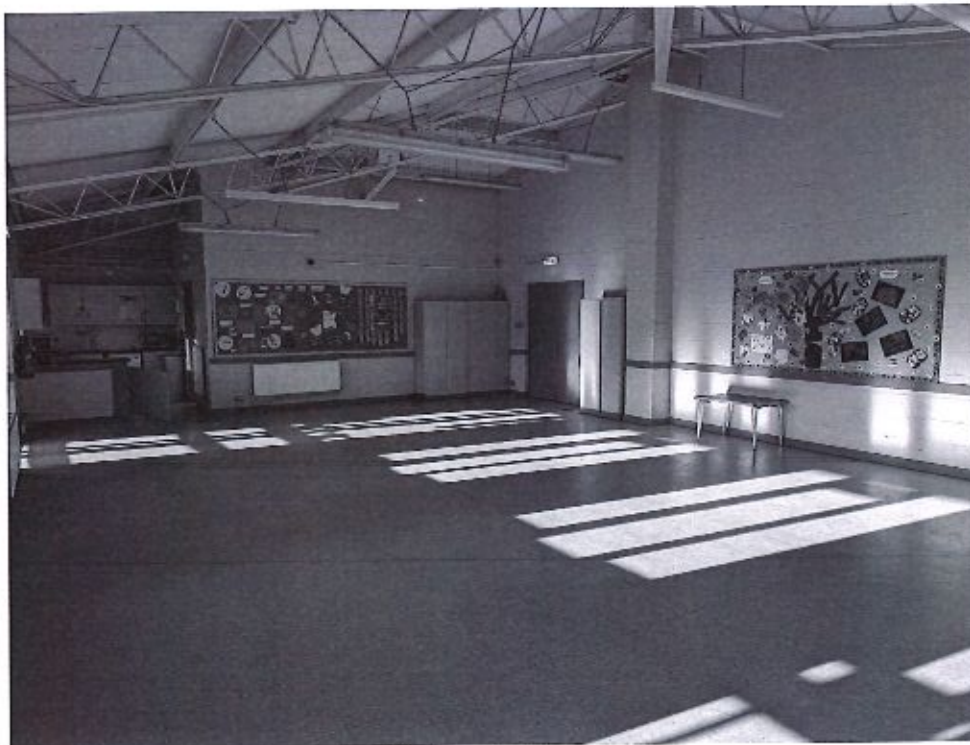
Photograph 44

Photograph:	General view
Defect:

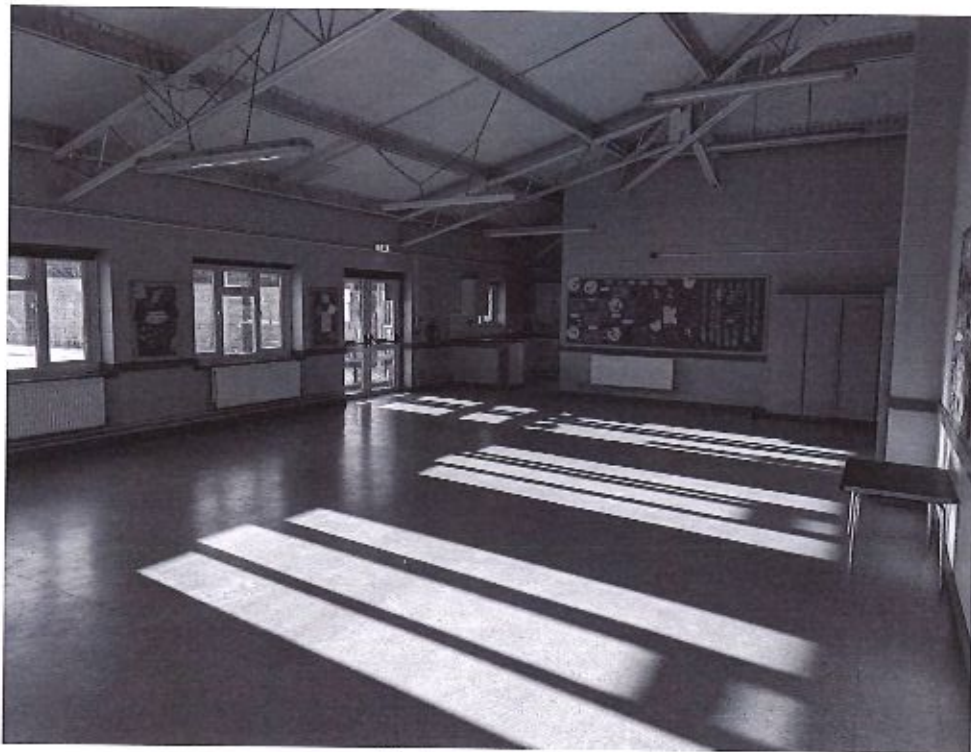
Photograph 45

Photograph:	General view
Defect:

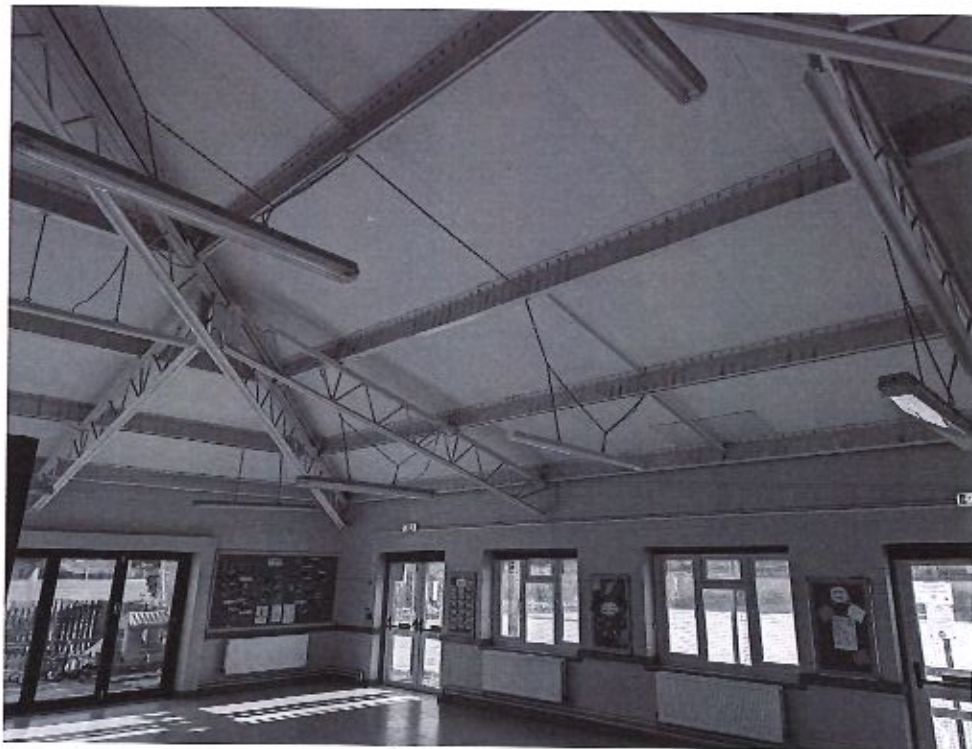
Photograph 46

Photograph:	Ceiling Main Hall
Defect:

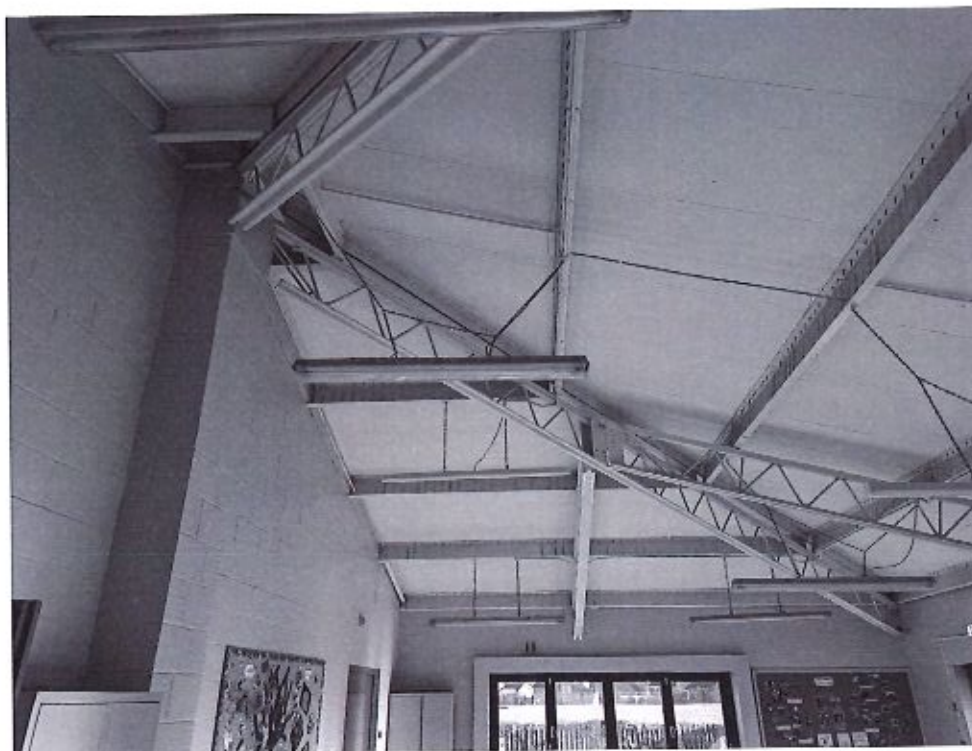
Photograph 47

Photograph:	Ceiling Main Hall
Defect:

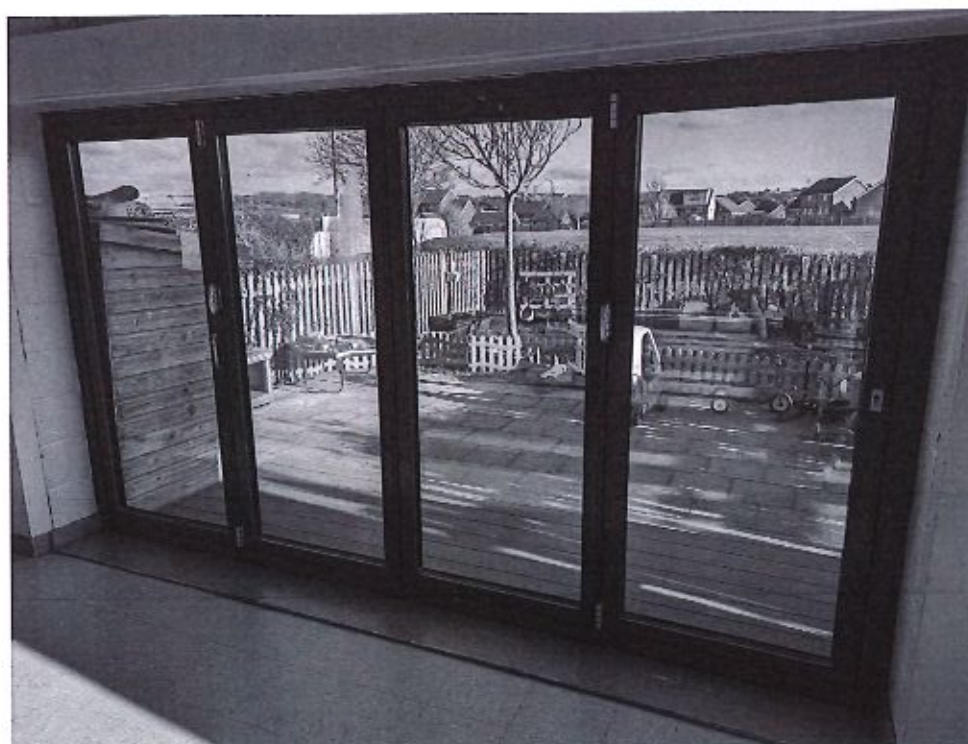
Photograph 52

Photograph:	Folding doors to external area
Defect:

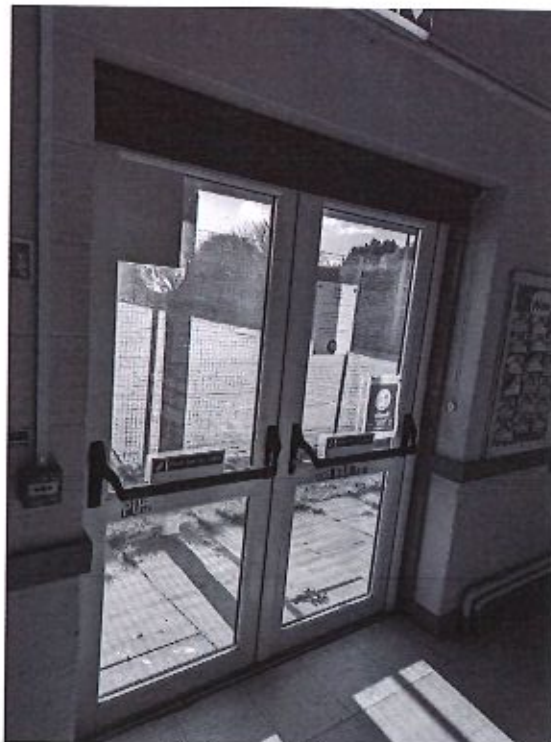
Photograph 54

Photograph:	Fire escape doors from main hall
Defect:

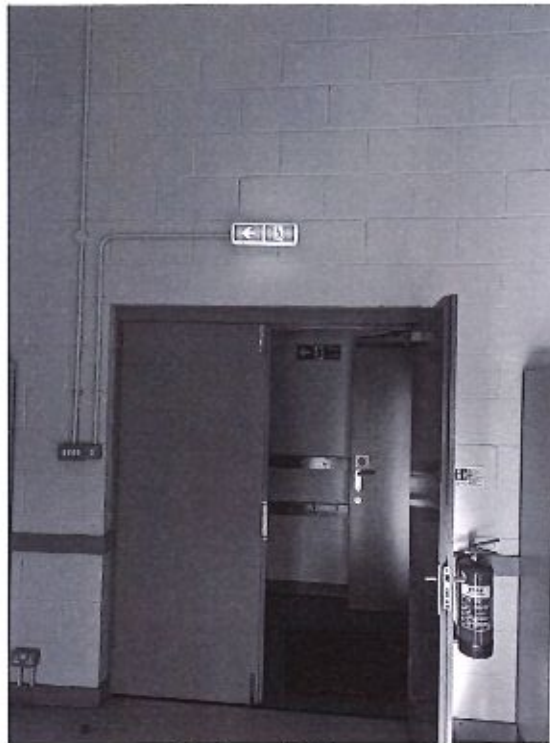
Photograph 55

Photograph:	Entrance doors into main hall
Defect:

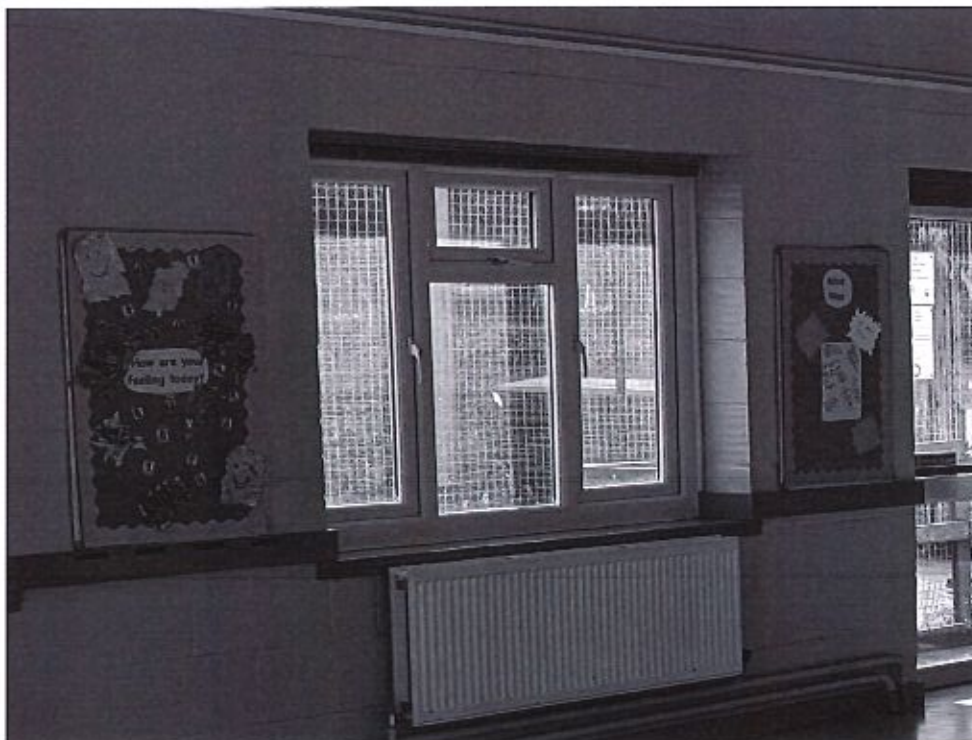
Photograph 56

Photograph:	Main Hall windows
Defect:

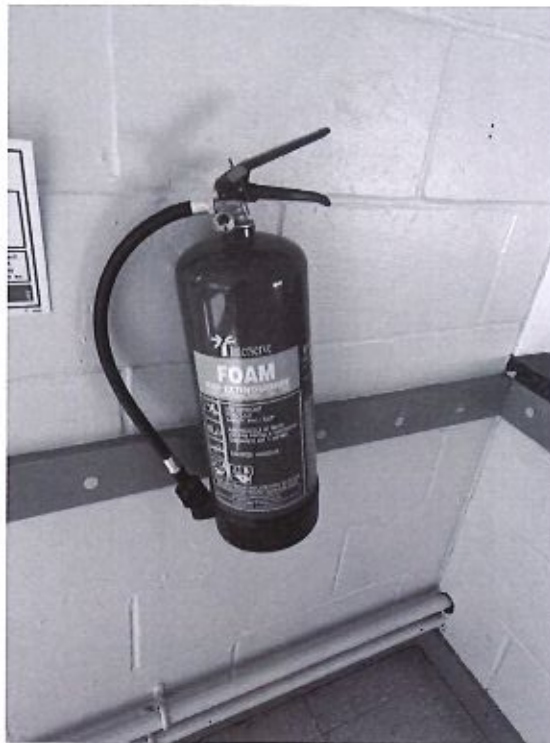
Photograph 57

Photograph:	Wall mounted fire extinguishers
Defect:

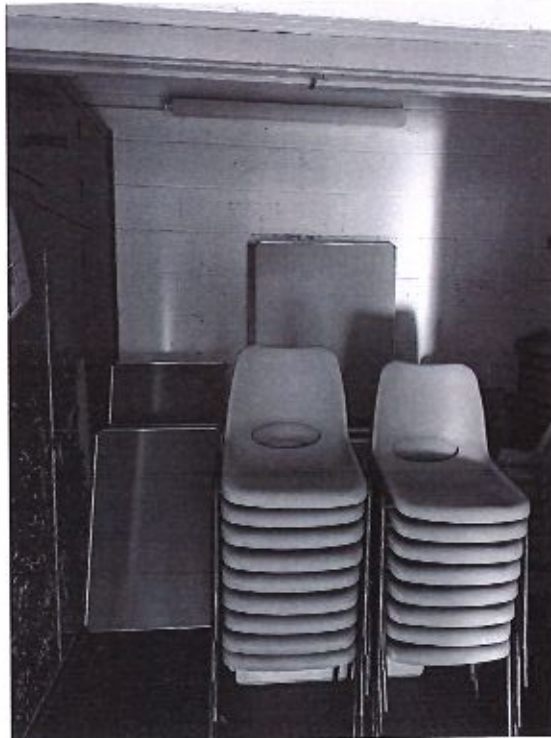
Photograph 60

Photograph:	General view
Defect:

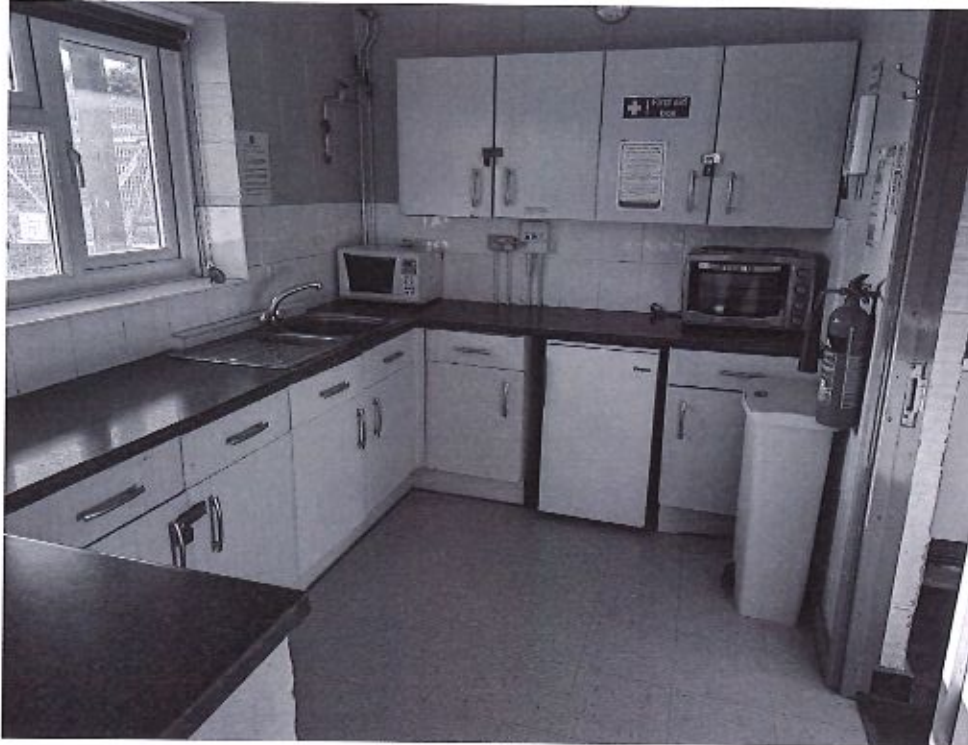
Photograph 61

Photograph:	General view
Defect:

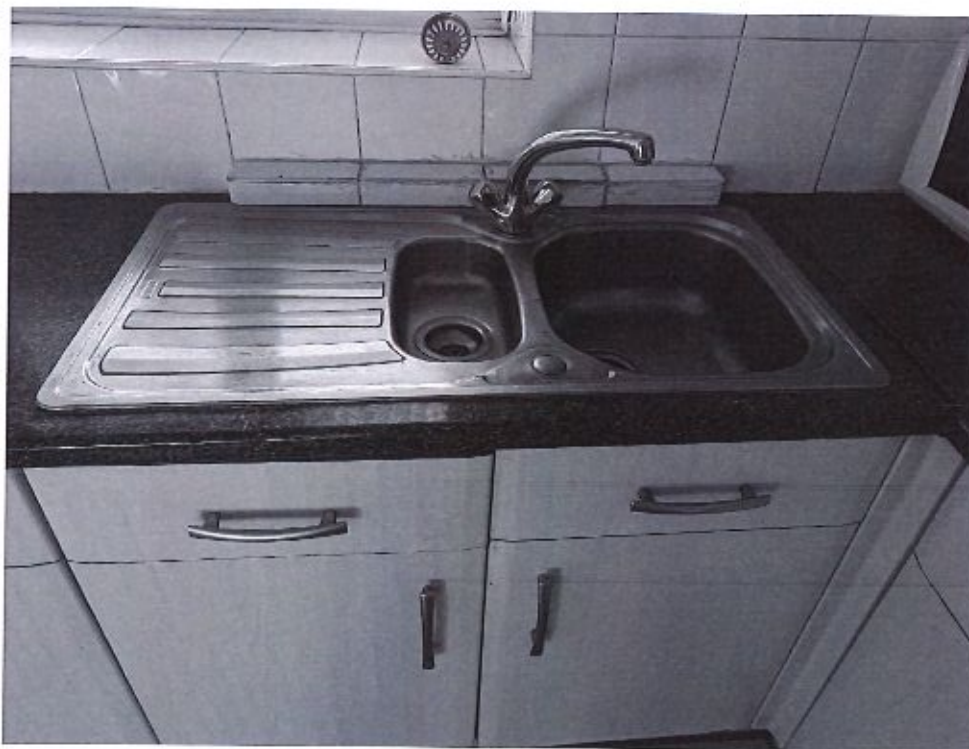
Photograph 62

Photograph:	Inset sink
Defect:

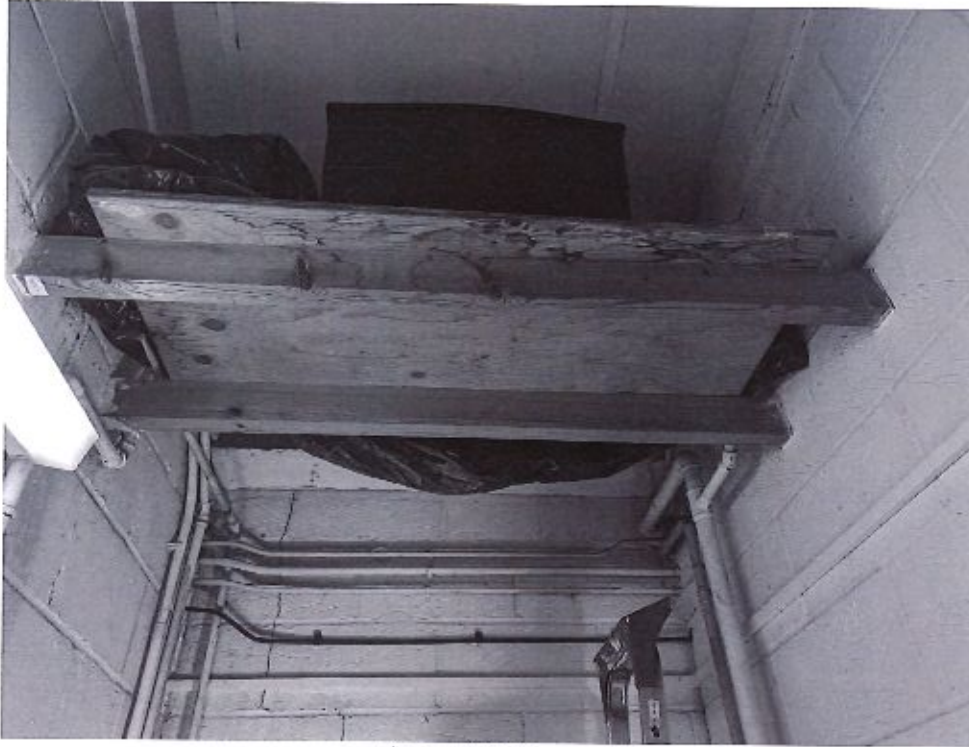
Photograph 65

Photograph:	Water tank above boiler
Defect:

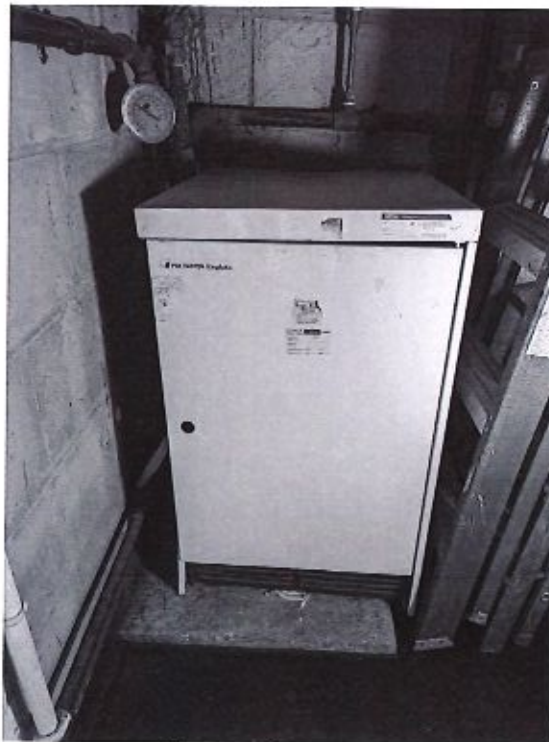
Photograph 66

Photograph:	Boiler
Defect:

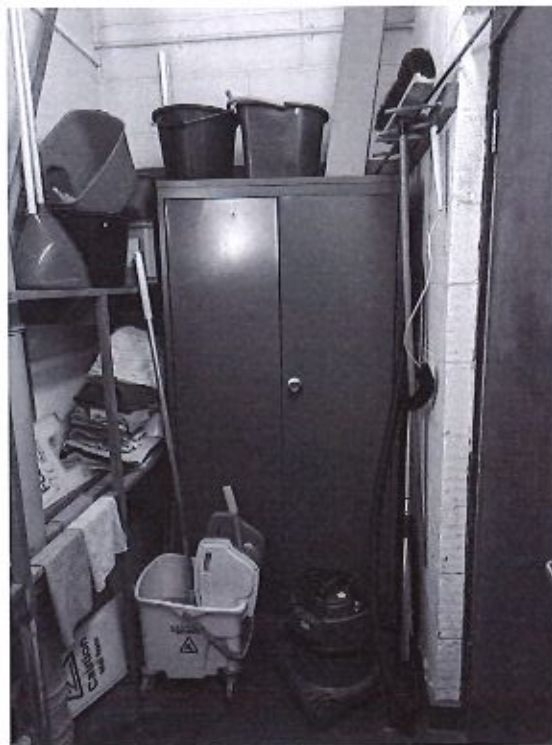
Photograph 67

Photograph:	Storage
Defect:

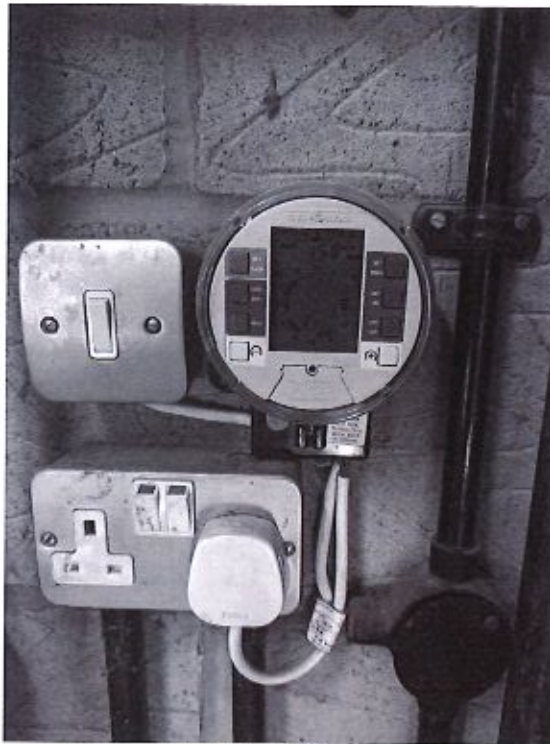
Photograph 69

Photograph:	Boiler control timer
Defect:

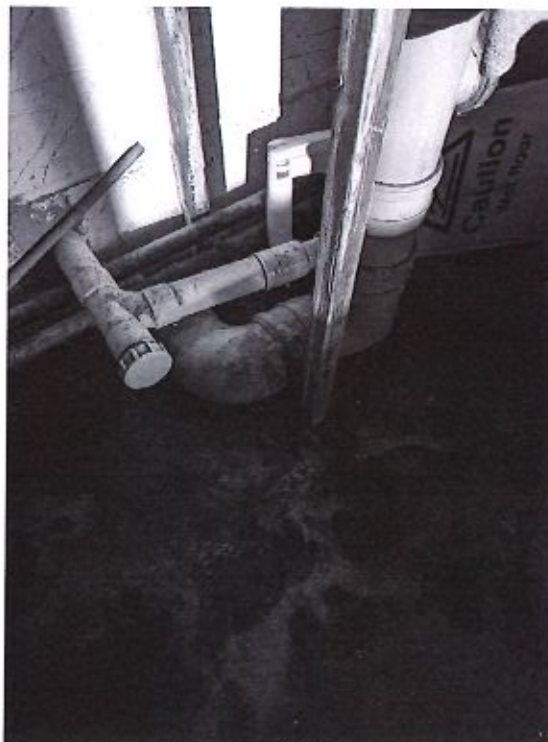
Photograph 70

Photograph:	Floor and drainage connections
Defect:	Evidence of leakage from pipework and damage to carpet

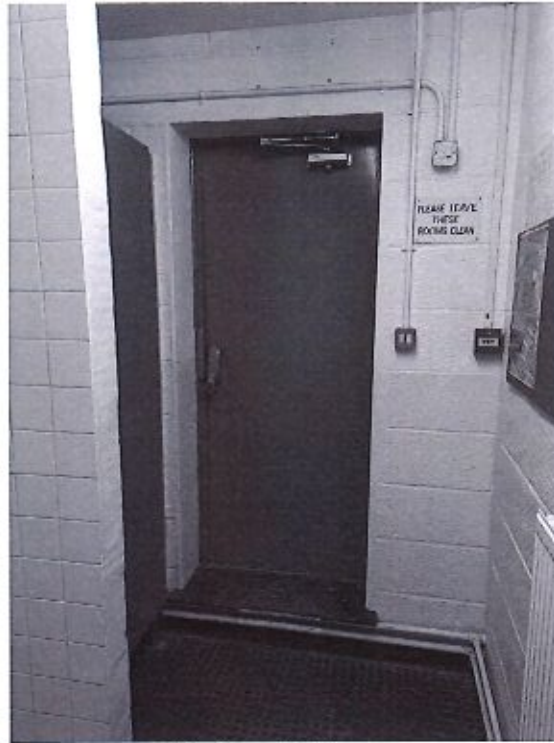
Photograph 71

Photograph:	Entrance door
Defect:

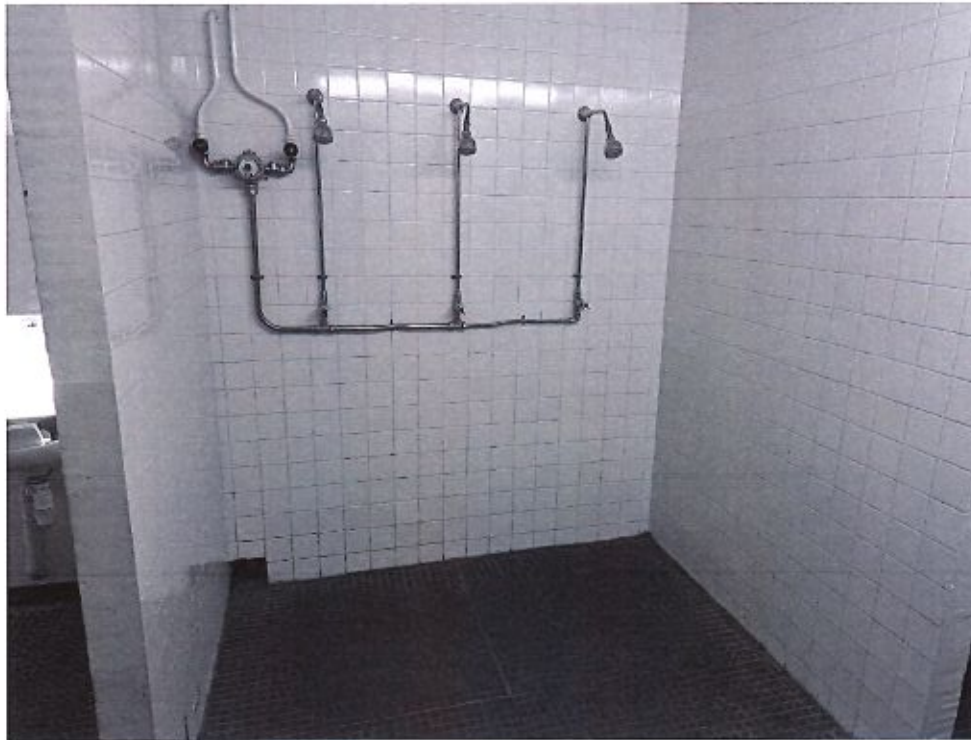
Photograph 72

Photograph:	Shower area
Defect:

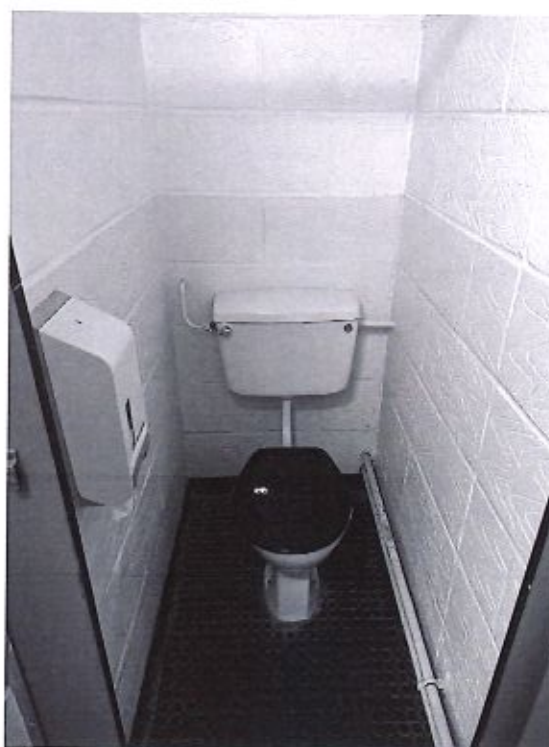
Photograph 78

Photograph:	WC cubicle
Defect:	Cubicle door frame needs re-fixing

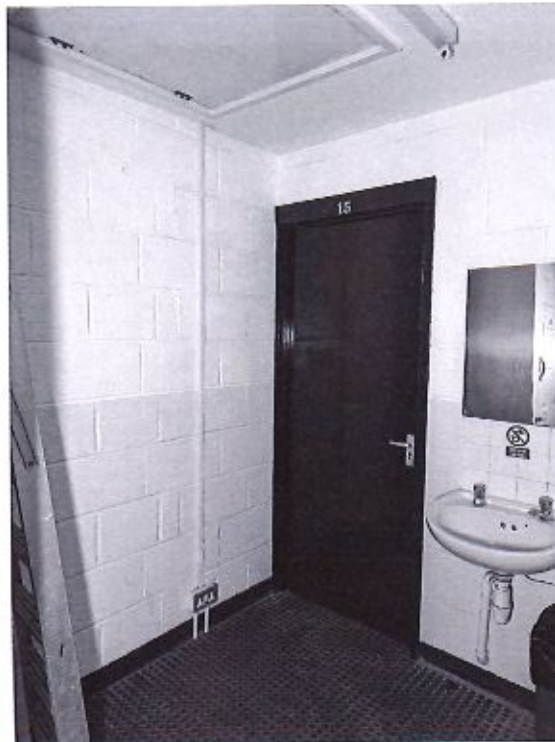
Photograph 79

Photograph:	Hand basin and communicating Door to changing Room 2
Defect:

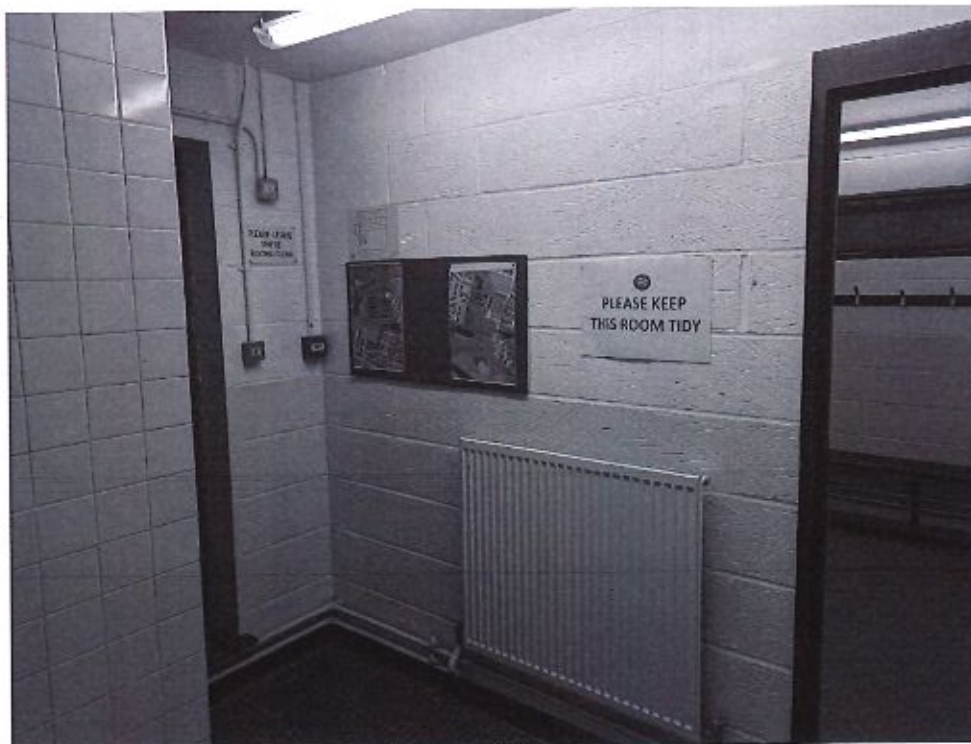
Photograph 80

Photograph:	Radiator
Defect:

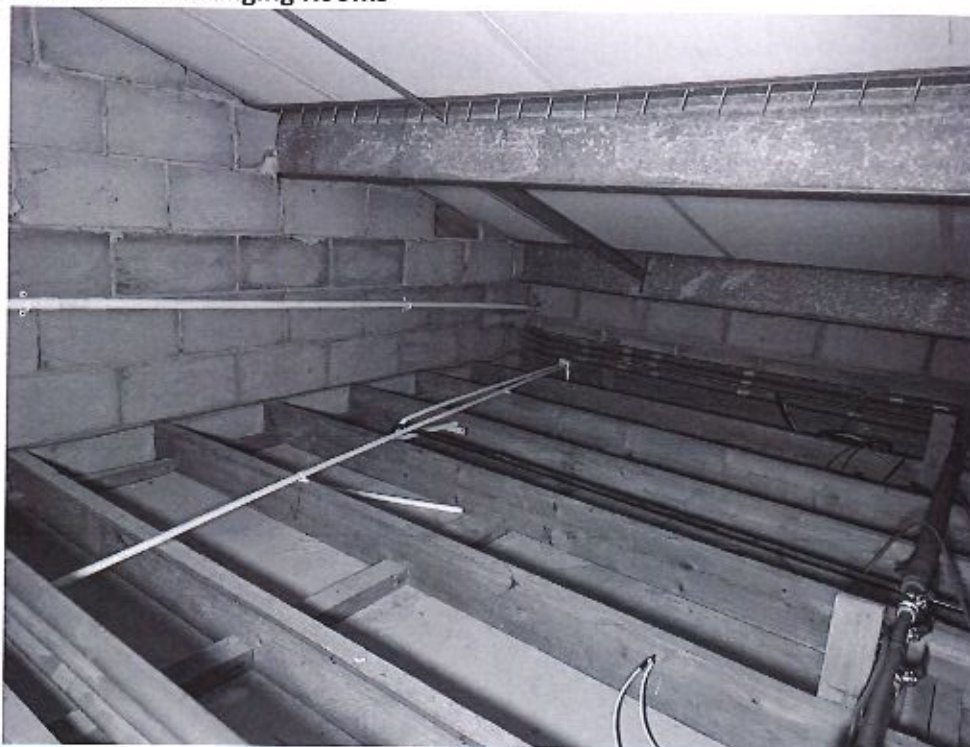
Photograph 82

Photograph:	Roof structure and ceiling
Defect:

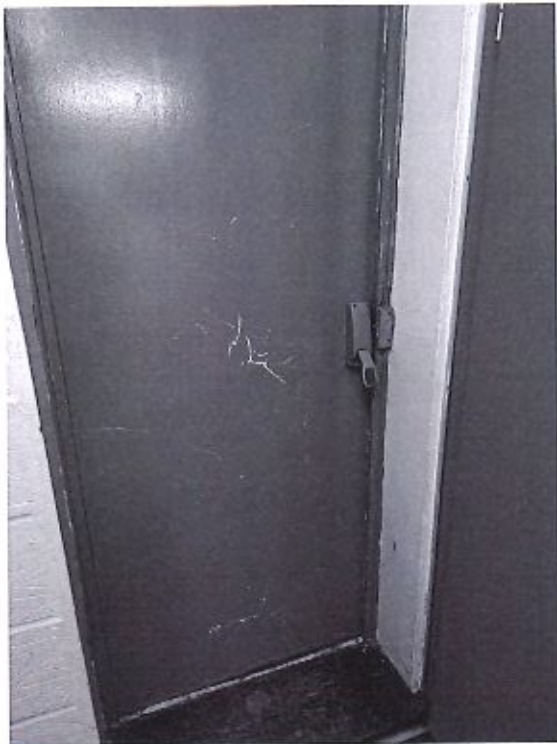
Photograph 87

Photograph:	Entrance door
Defect:

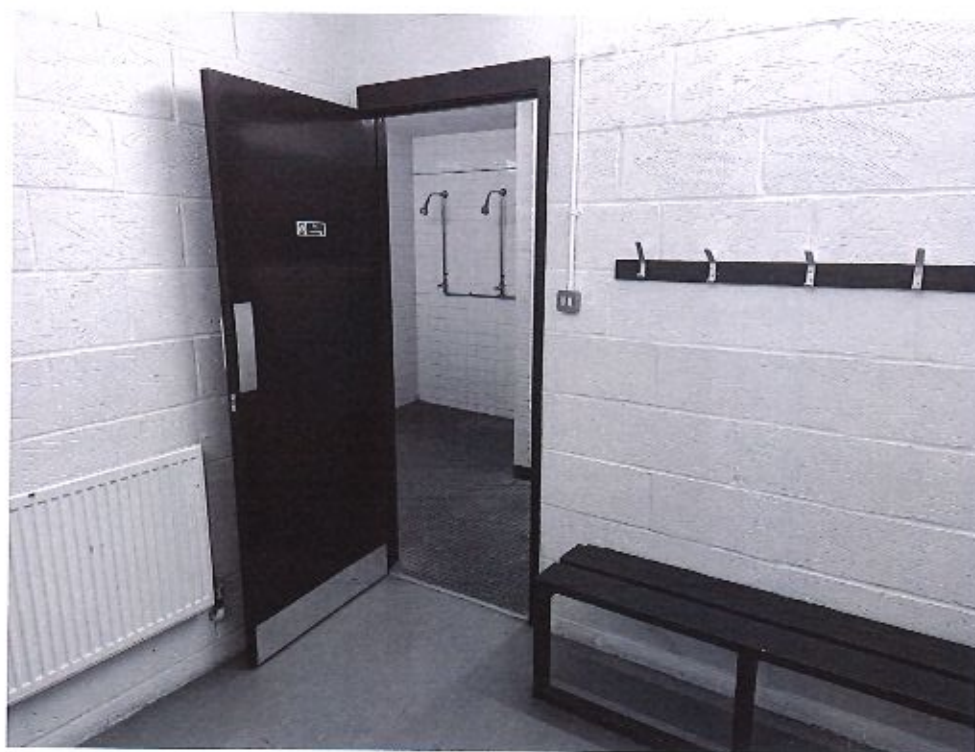
Photograph 90

Photograph:	Changing area
Defect:

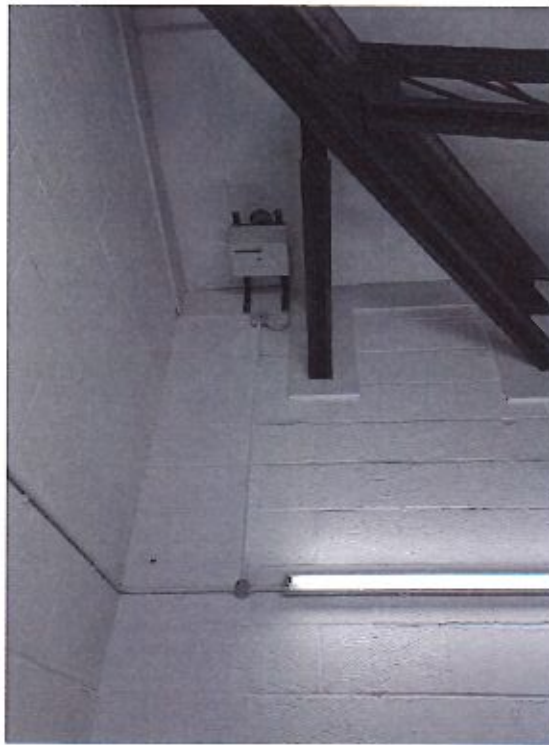
Photograph 93

Photograph:	Ceiling fan above changing area
Defect:

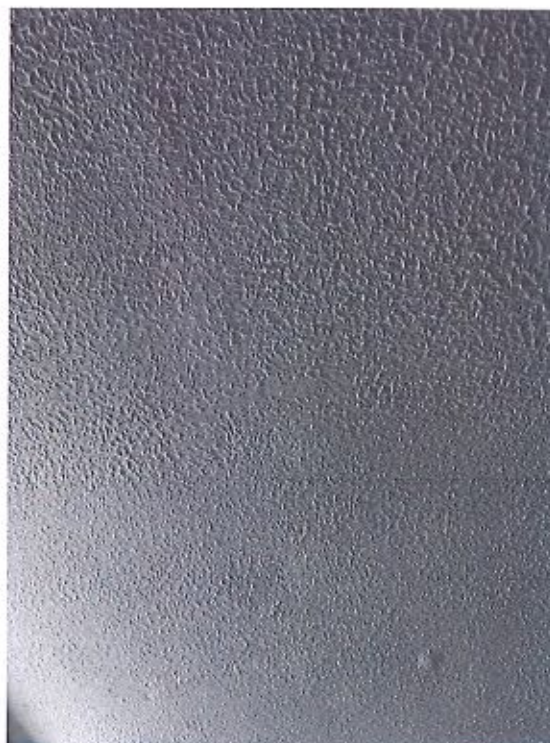
Photograph 94

Photograph:	Textured ceiling finish
Defect:	This type of coating can contain asbestos

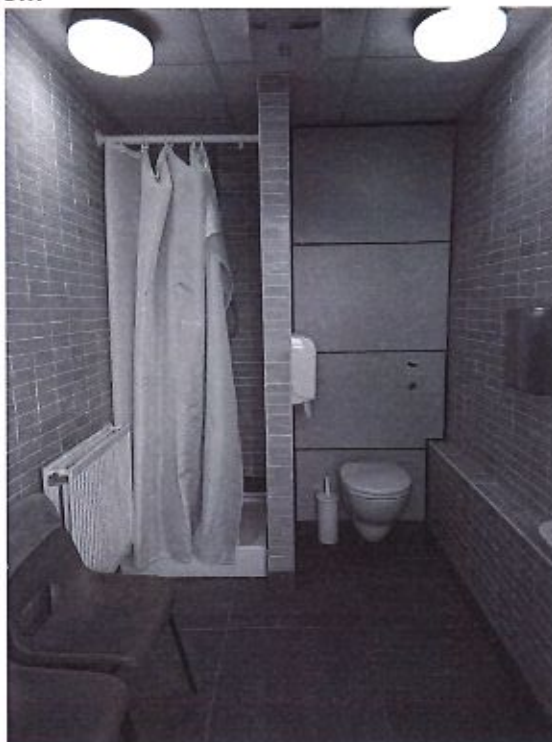
Photograph 95

Photograph:	General view
Defect:
