DRAFT Minutes of the meeting of the Leisure, Amenities & Environment Committee held at Community House on Tuesday 9th January 2024 at 7.30pm

Property Condition Report

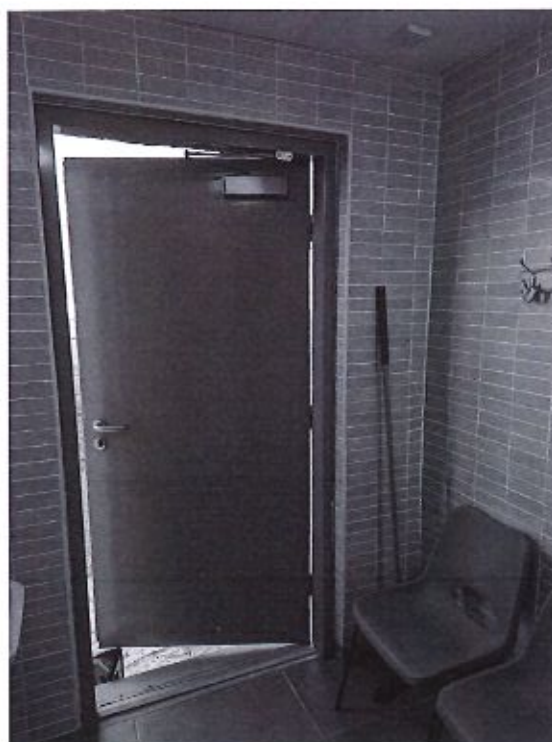
Photograph 96

Photograph:	Door to Referee's room
Defect:

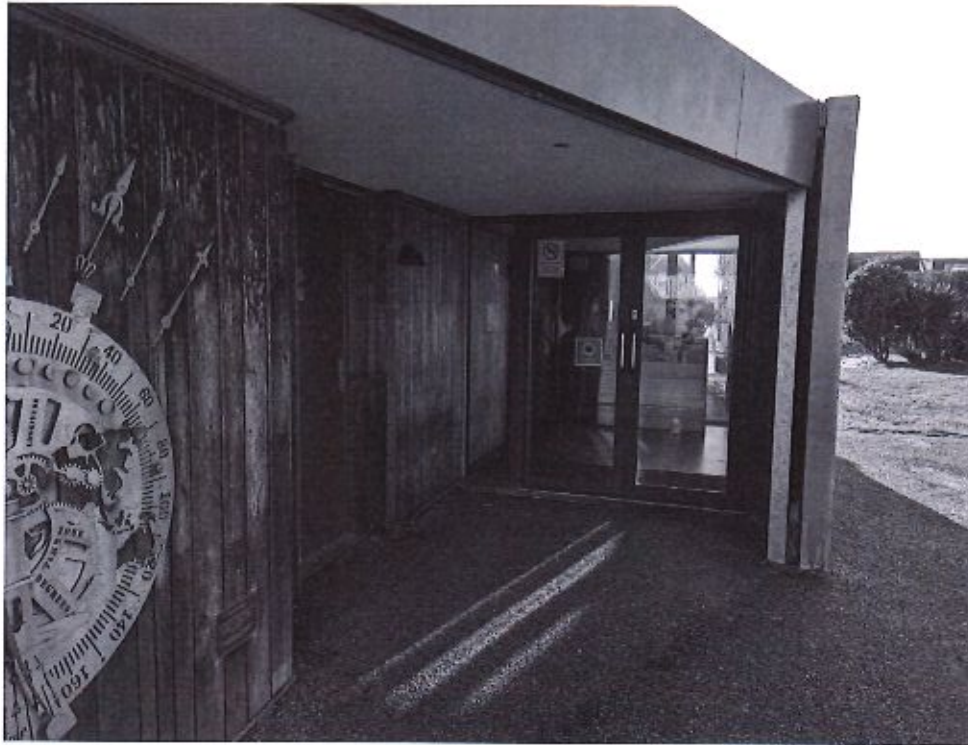
Photograph 97

Photograph:	Entrance doors and canopy
Defect:

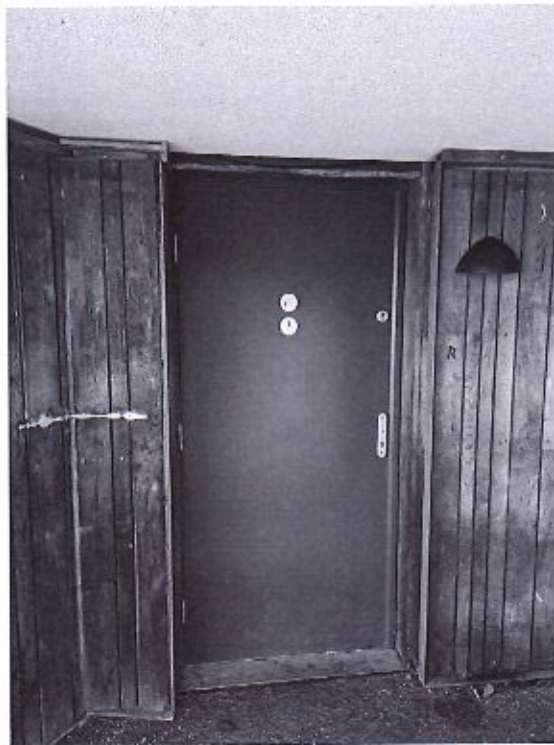
Photograph 99

Photograph:	External door to accessible WC
Defect:

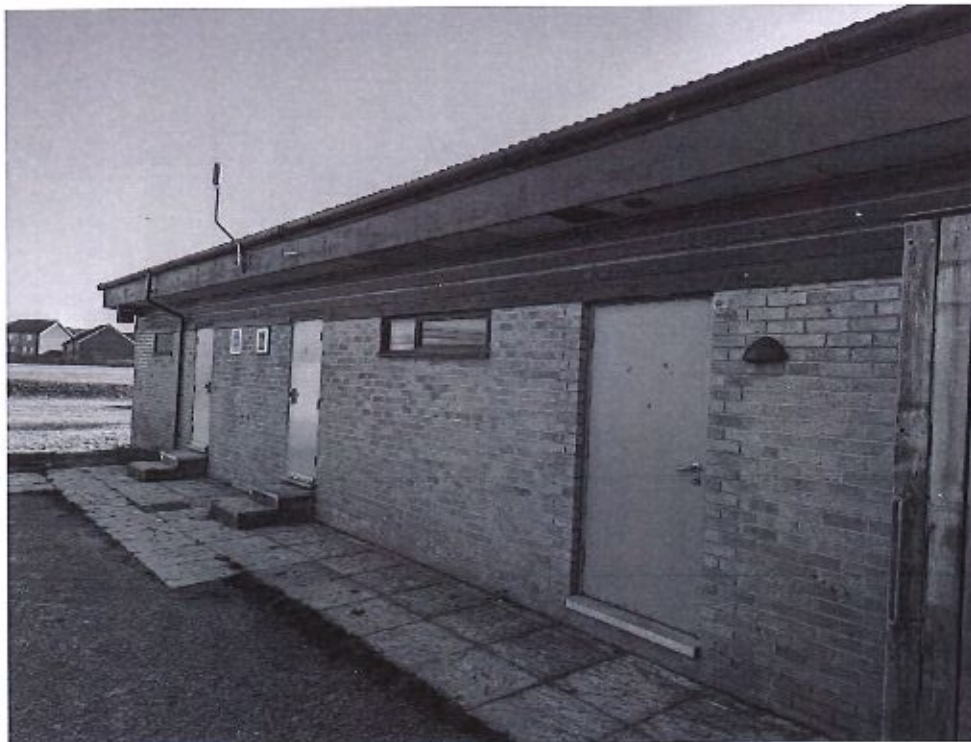
Photograph 100

Photograph:	External view of Changing Rooms (north elevation)
Defect:

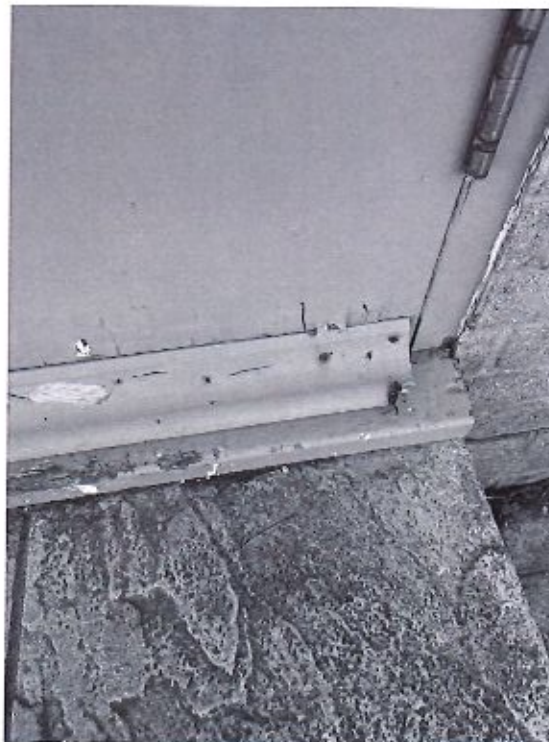
Photograph 102

Photograph:	Timber doors to Changing Rooms 1 & 2
Defect:	Some deterioration and decay to doors

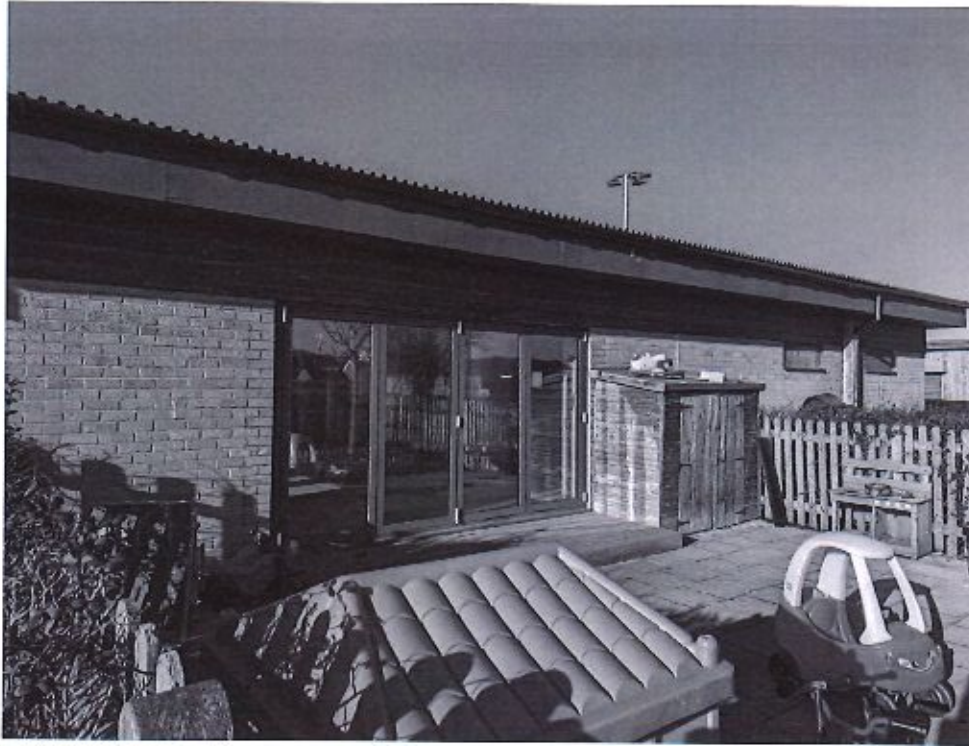
Photograph 105

Photograph:	Fenced patio/play area
Defect:

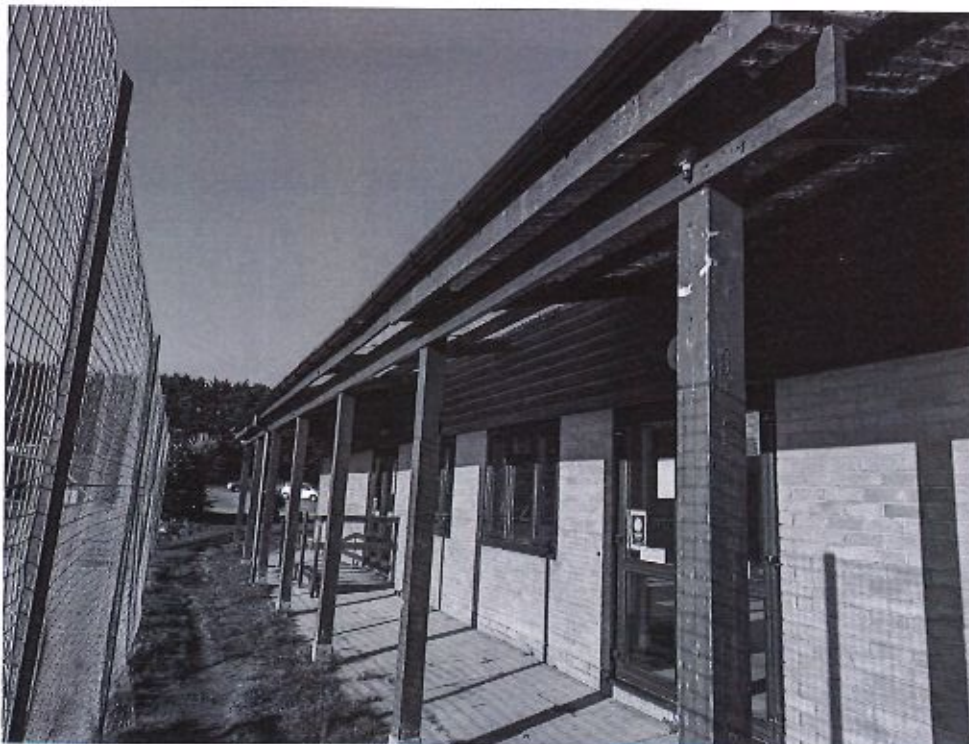
Photograph 106

Photograph:	Verandah to south elevation
Defect:

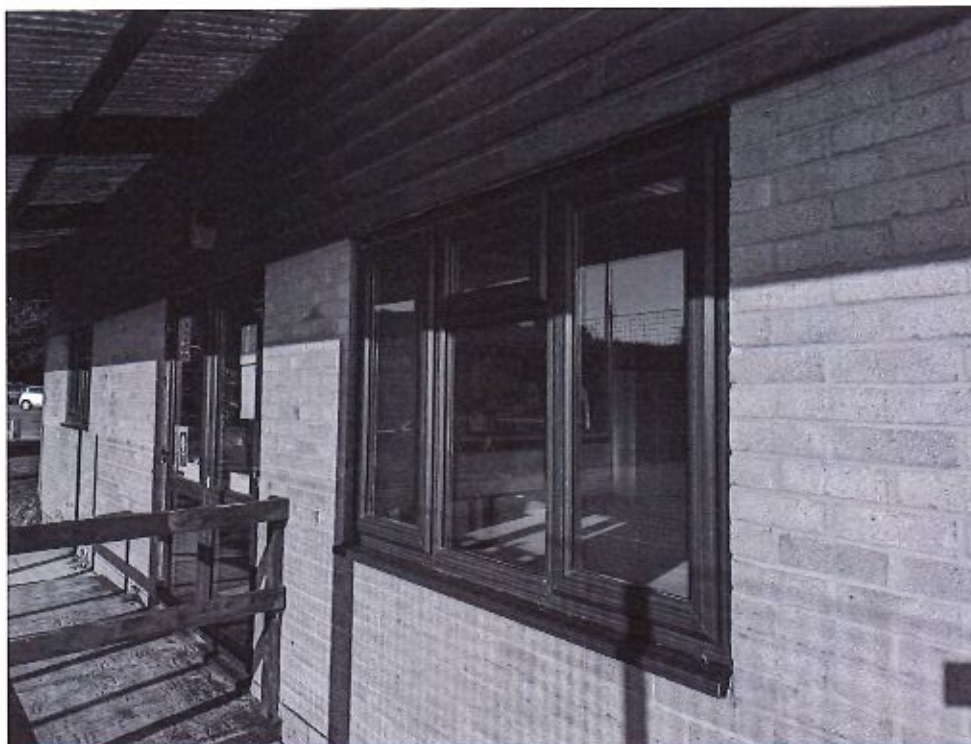
Photograph 107

Photograph:	External view of uPVC windows and fire escape doors
Defect:

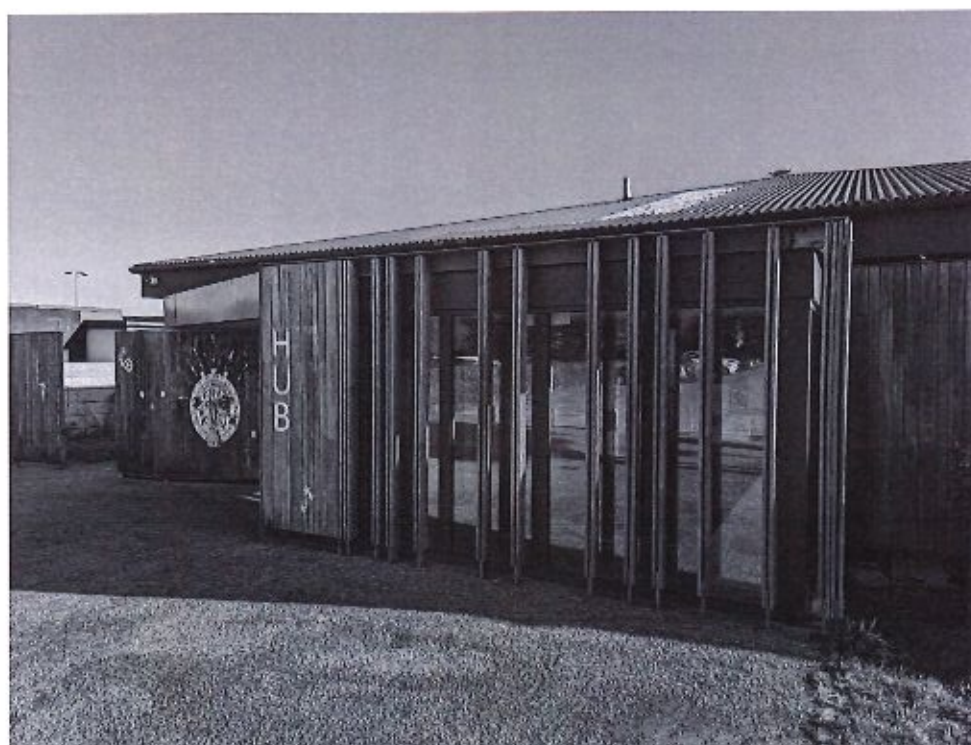
Photograph 108

Photograph:	External view west elevation
Defect:

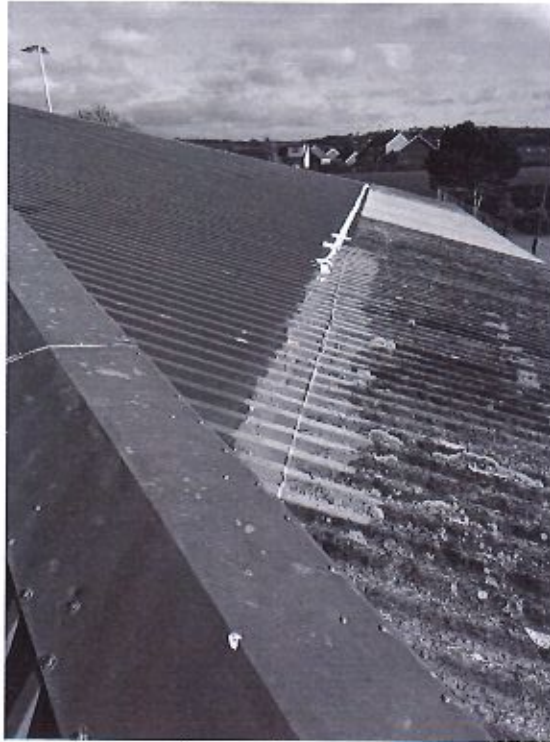
Photograph 109

Photograph:	Roof over south elevation and verandah
Defect:	Discolouration and deterioration of translucent sheets

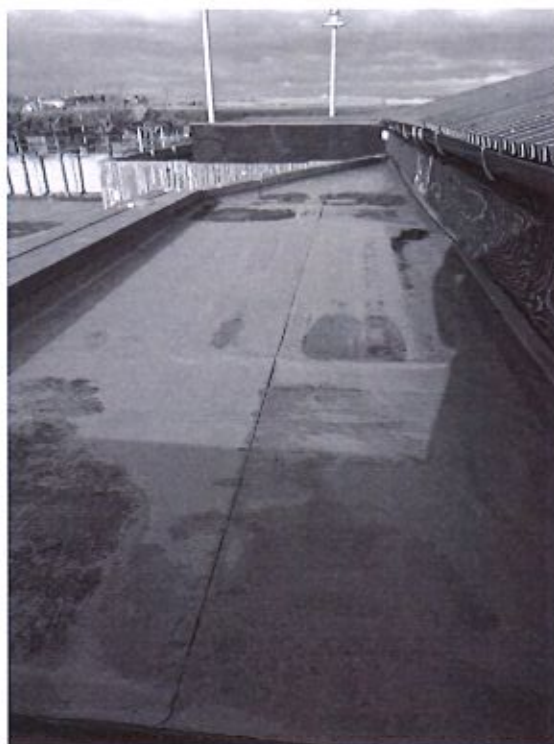
Photograph 111

Photograph:	Single ply membrane flat roof over entrance foyer
Defect:

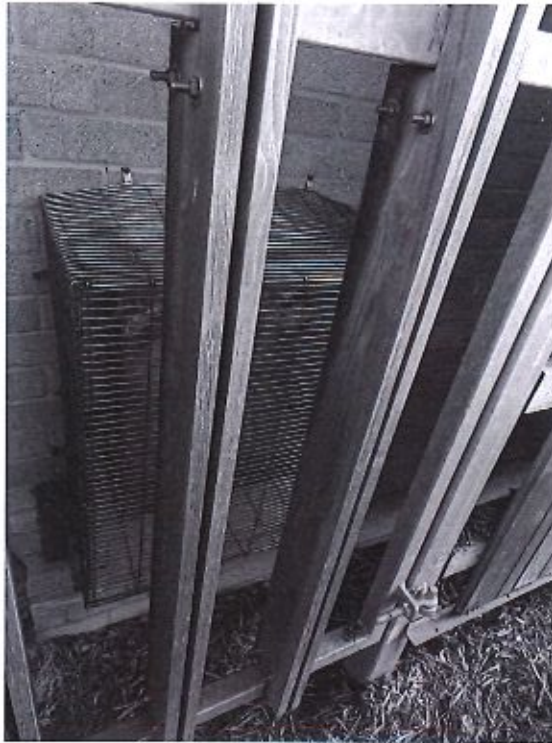
Photograph 113

Photograph:	Boiler flue in external wall
Defect:

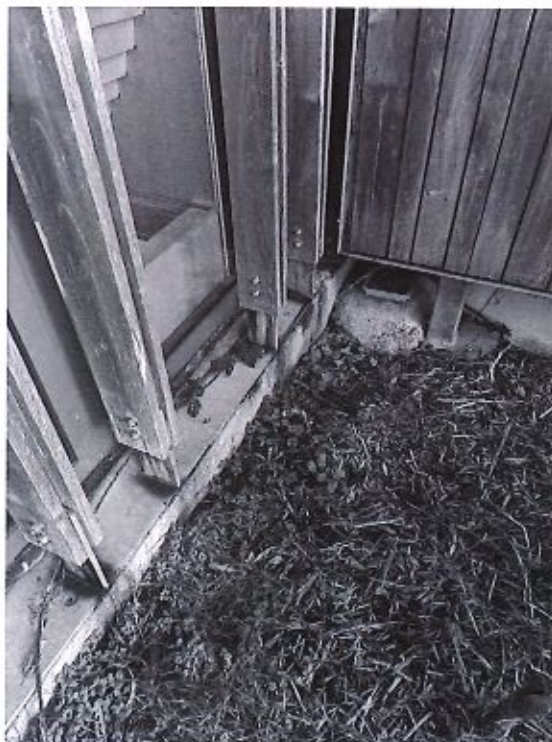
Photograph 114

Photograph:	Steel and timber cladding to entrance foyer
Defect:	Some rusting to steelwork
